A . D . M . A . T .

Anglo ~ Danish Maritime Archaeological Team

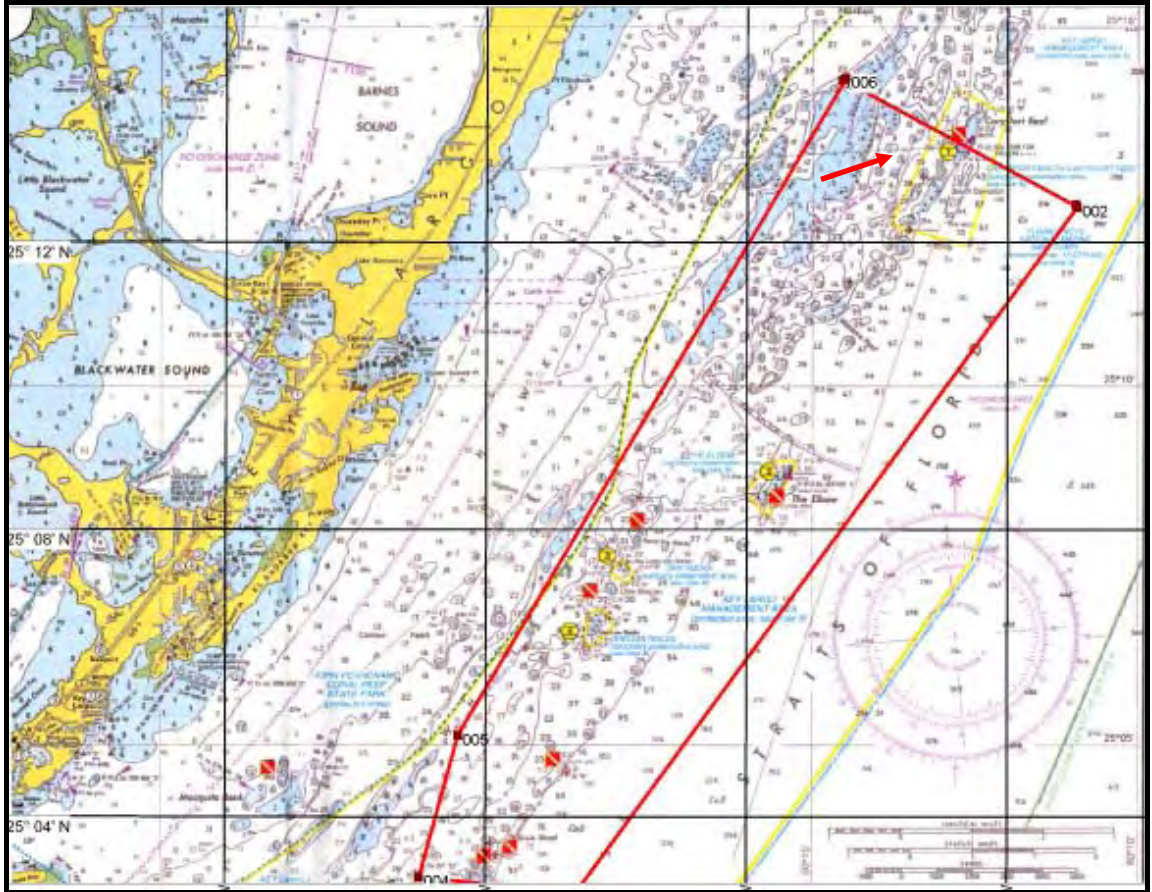
Illustration 4: Detailed local diving chart, showing the boundaries of ADMAT's permit area. The location of the Button Wreck is shown by the red arrow.

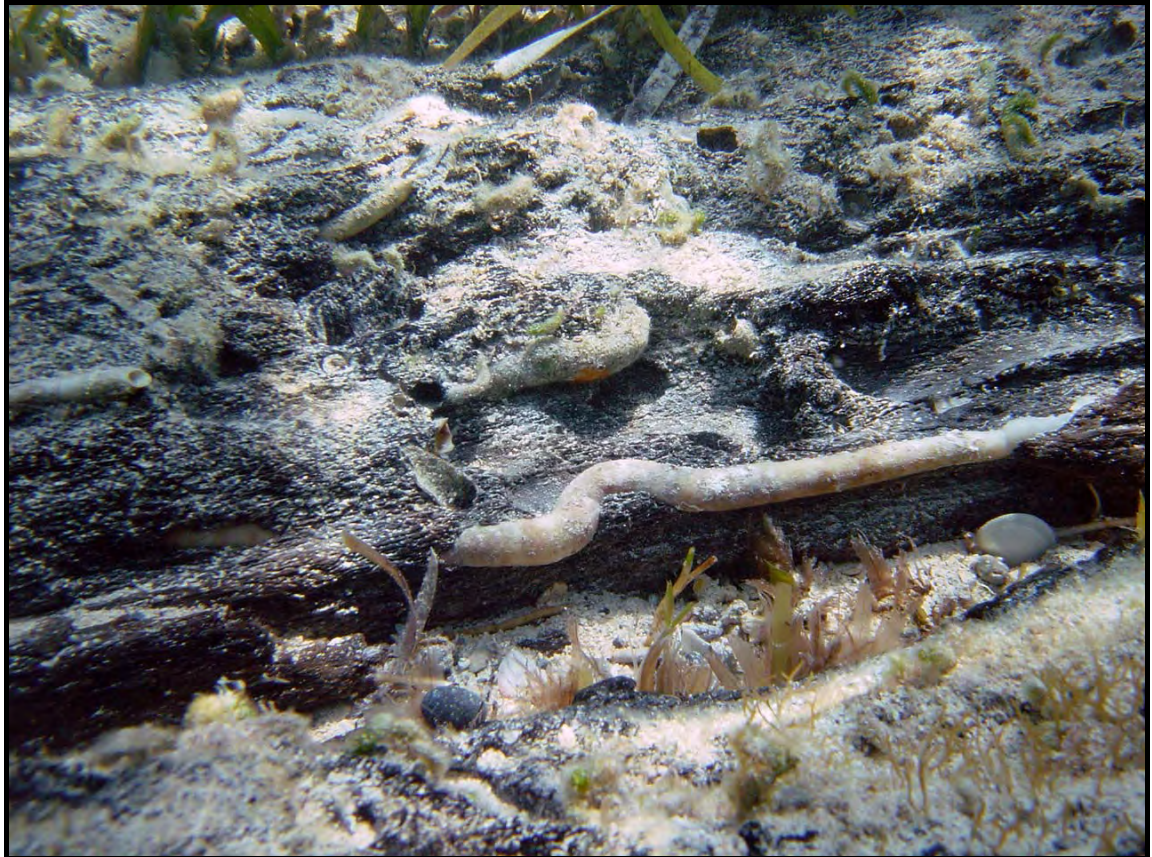
Illustration 34: Photograph of the erosion caused by shipworm, and the remains of the calcareous tubes, caused by burrowing worms (© ADMAT Archives - Spooner).

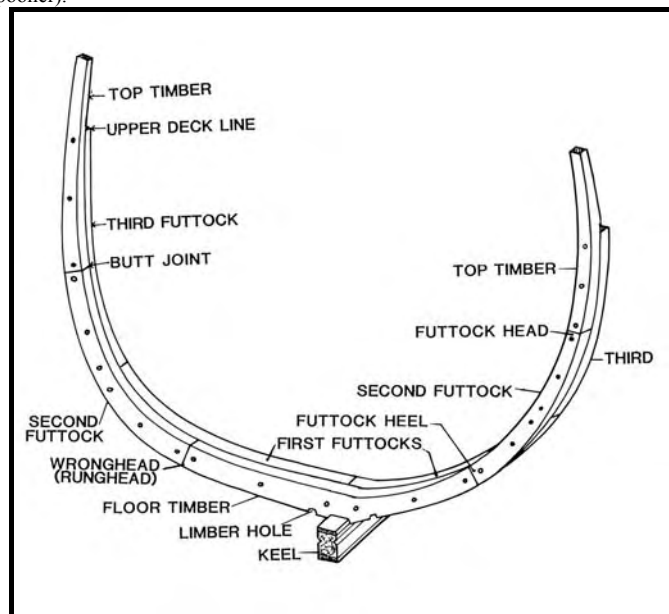
Illustration 35: An example of the positioning of framing and the technical names (© Steffy 1994).

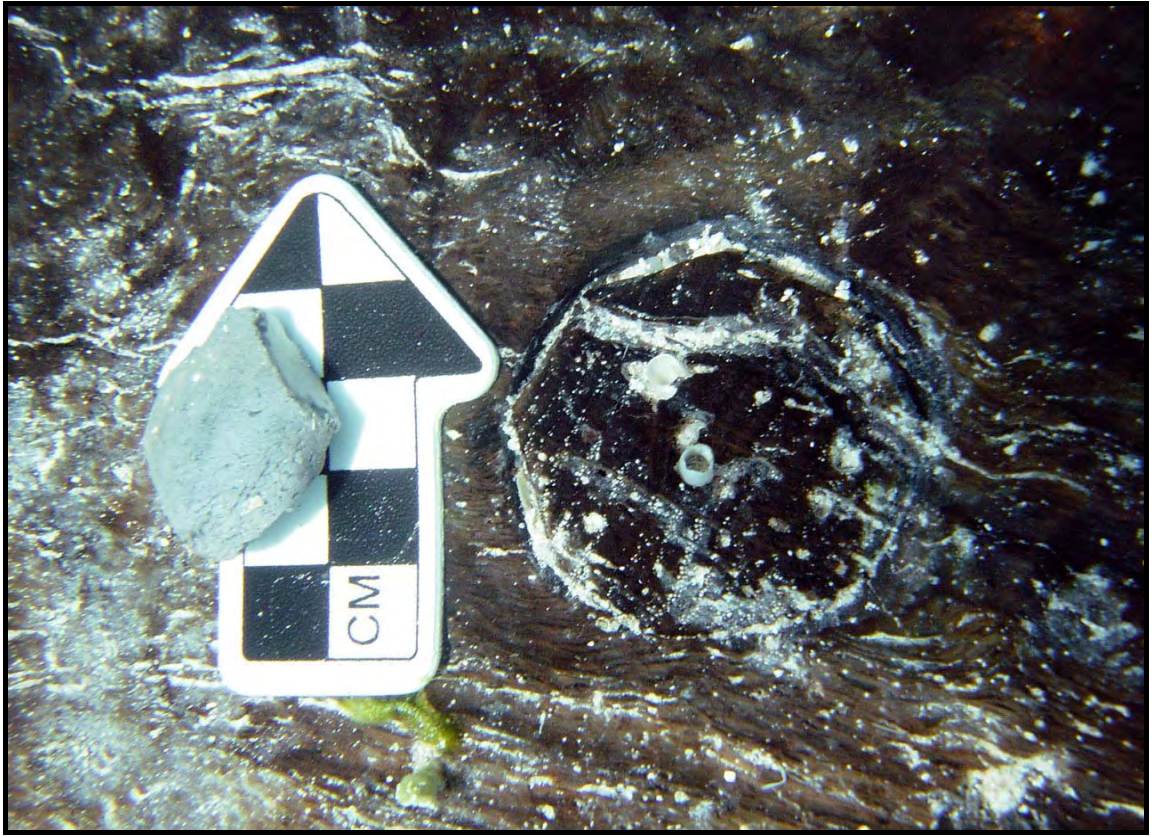
Illustration 36: A 4 cm Diam. wooden trunnel located in a floor on the Button Wreck (© ADMAT Archives - Spooner).

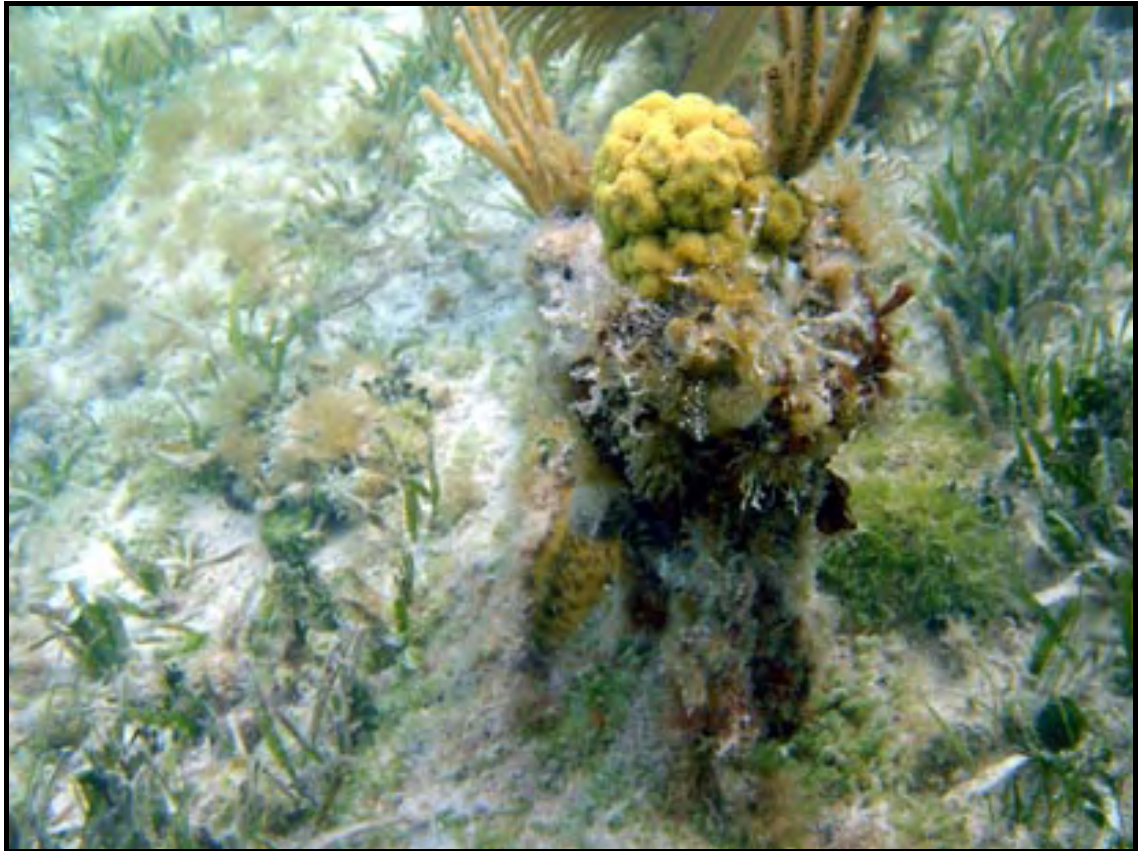
Illustration 38: Coral growth on an iron keel bolt to the south of the area surveyed on *The Button Wreck* (© ADMAT Archives – Spooner).

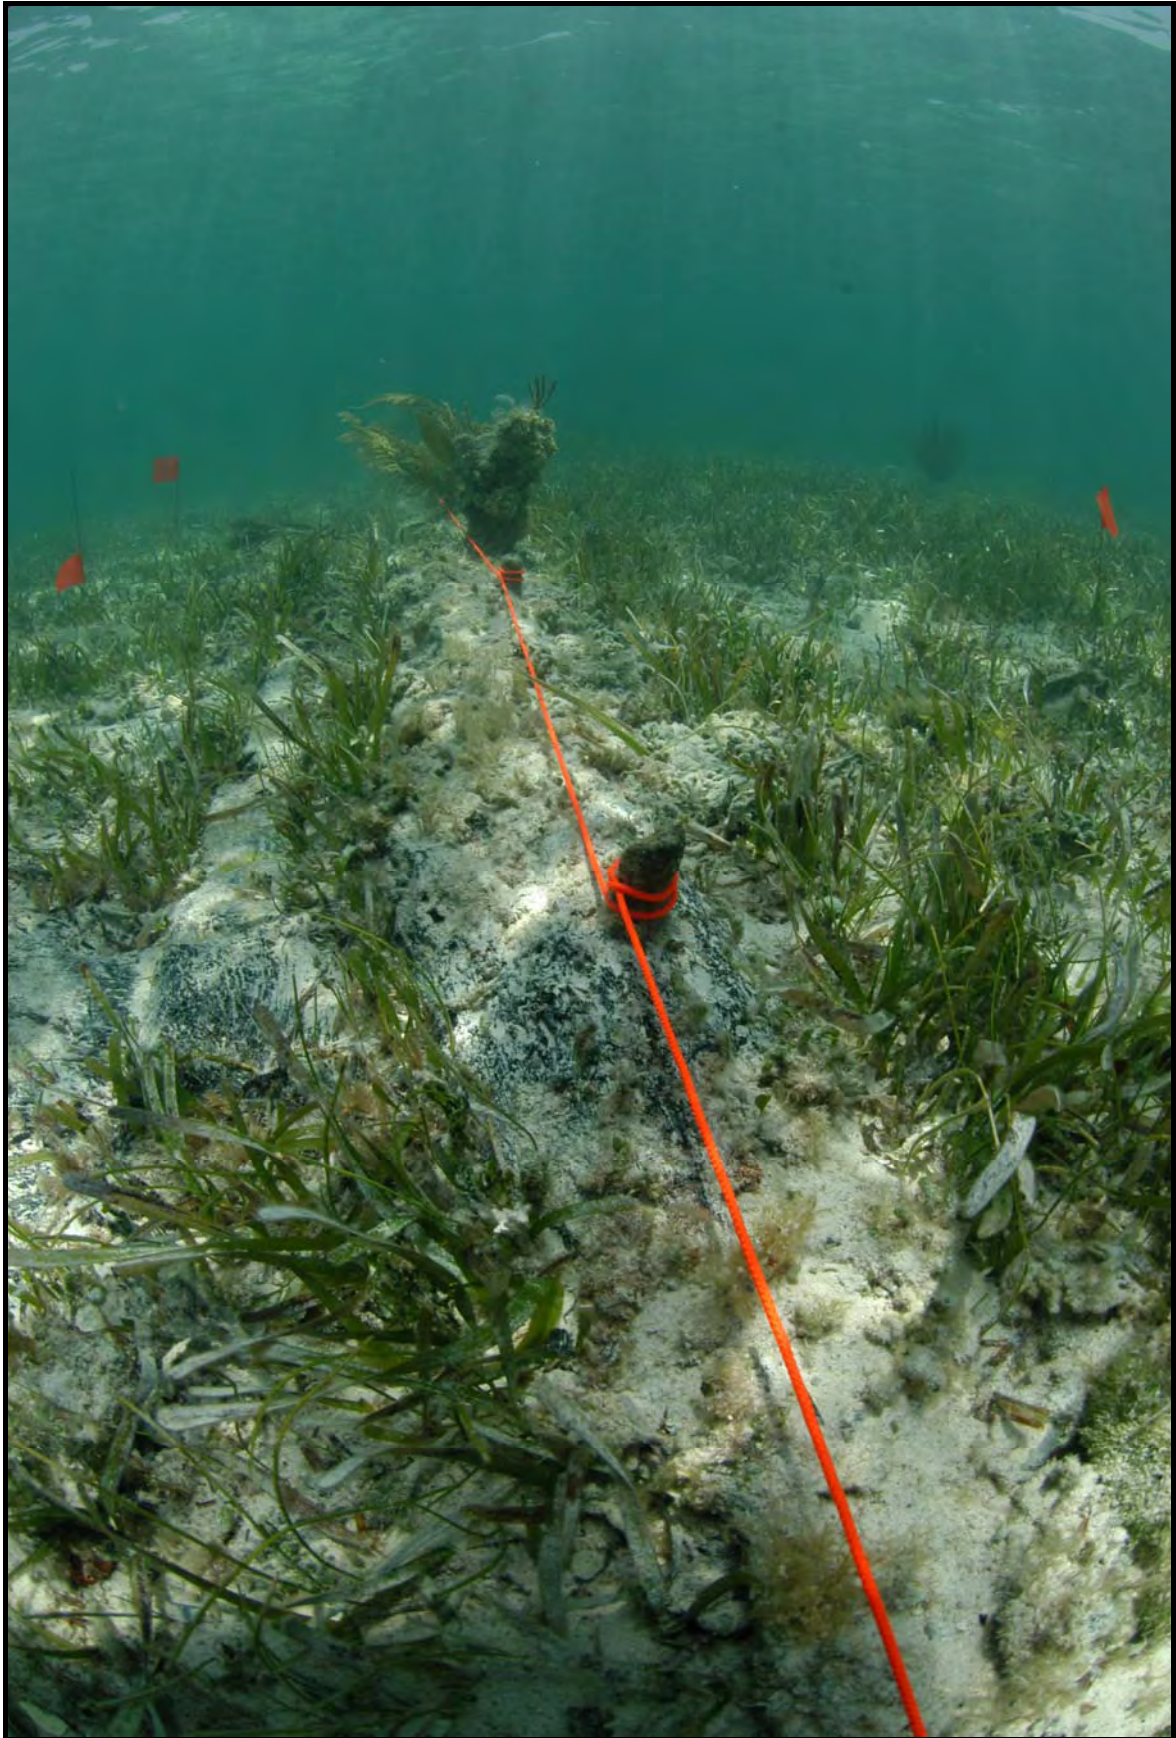
Illustration 43: The keelson with three visible keel bolts showing and day glow line tied down the central line prior to the grid being erected (© ADMAT Archives – Schomberg).

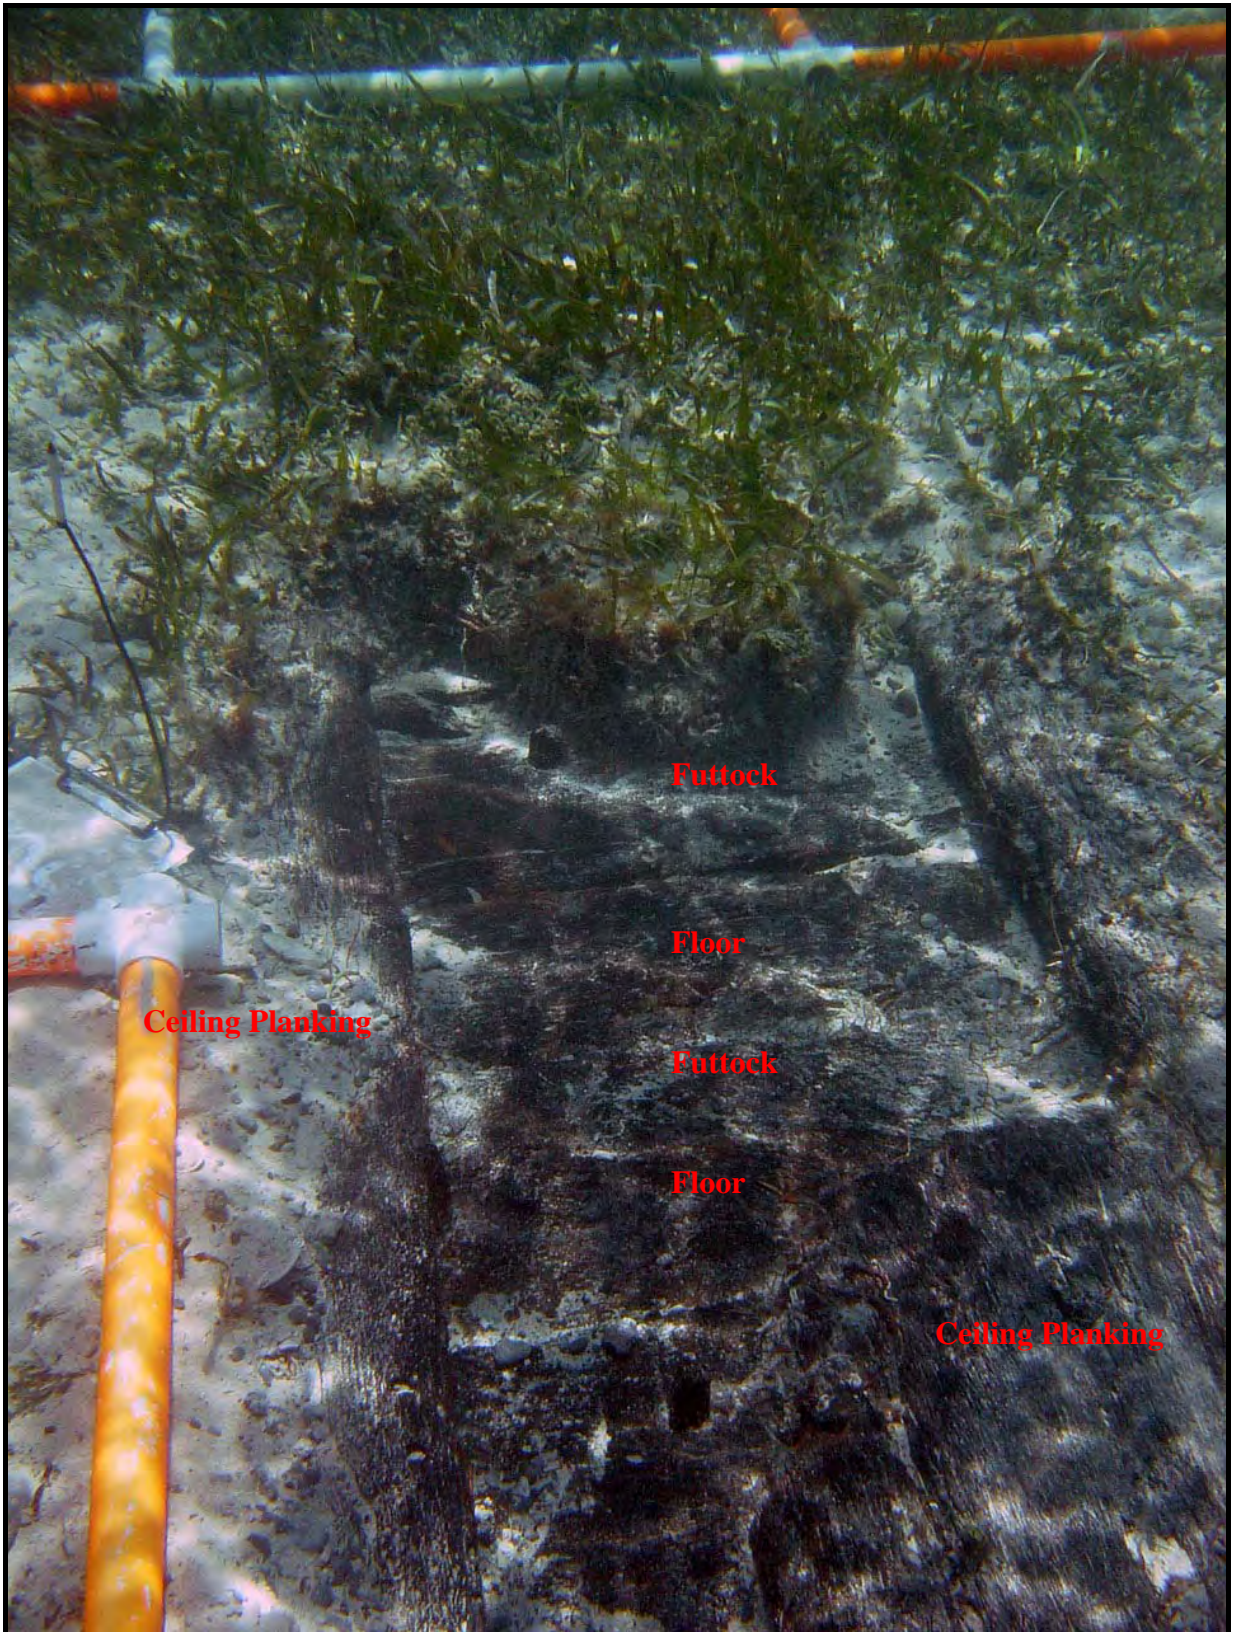
Illustration 45: Showing a section of missing ceiling planking, revealing the top of the floors and futtocks underneath on *The Button Wreck* (© ADMAT Archives – Spooner).

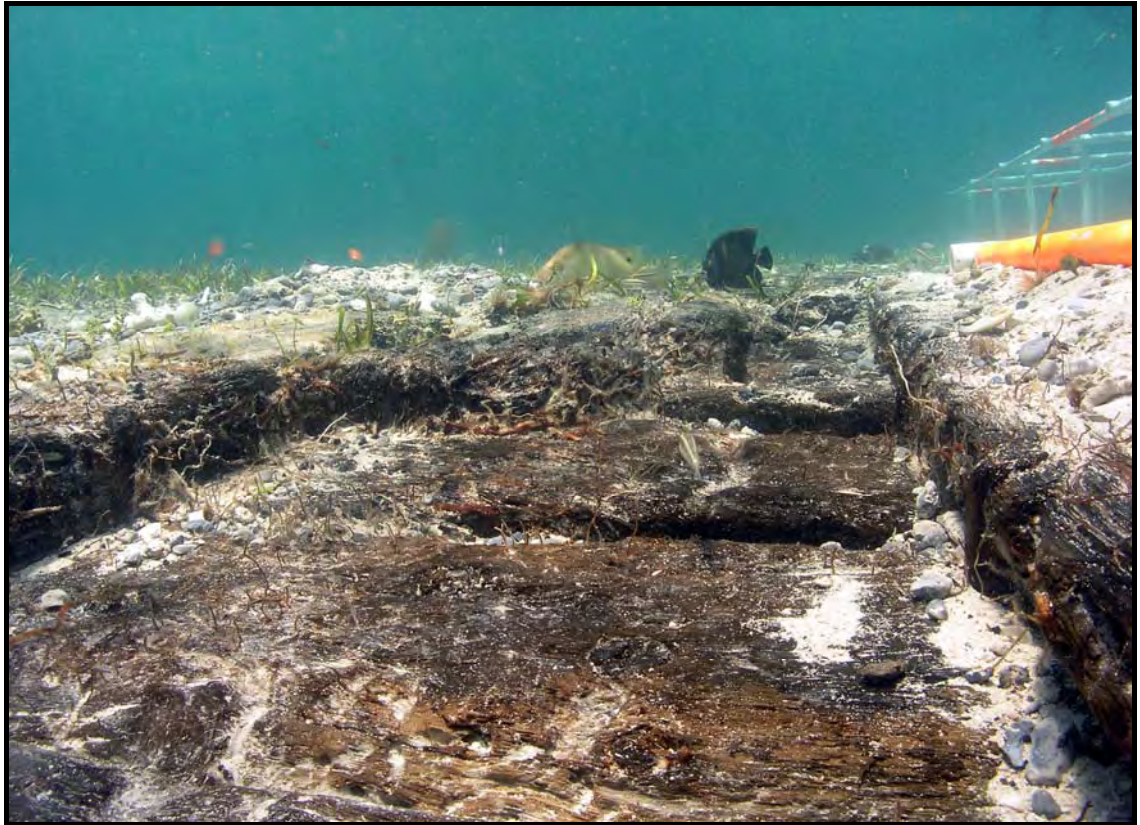
Illustration 46: Showing a section of missing ceiling planking, revealing the top of the floors and futtocks underneath the surface of which has been attacked by the sea grass (© ADMAT Archives – Shrimpton).

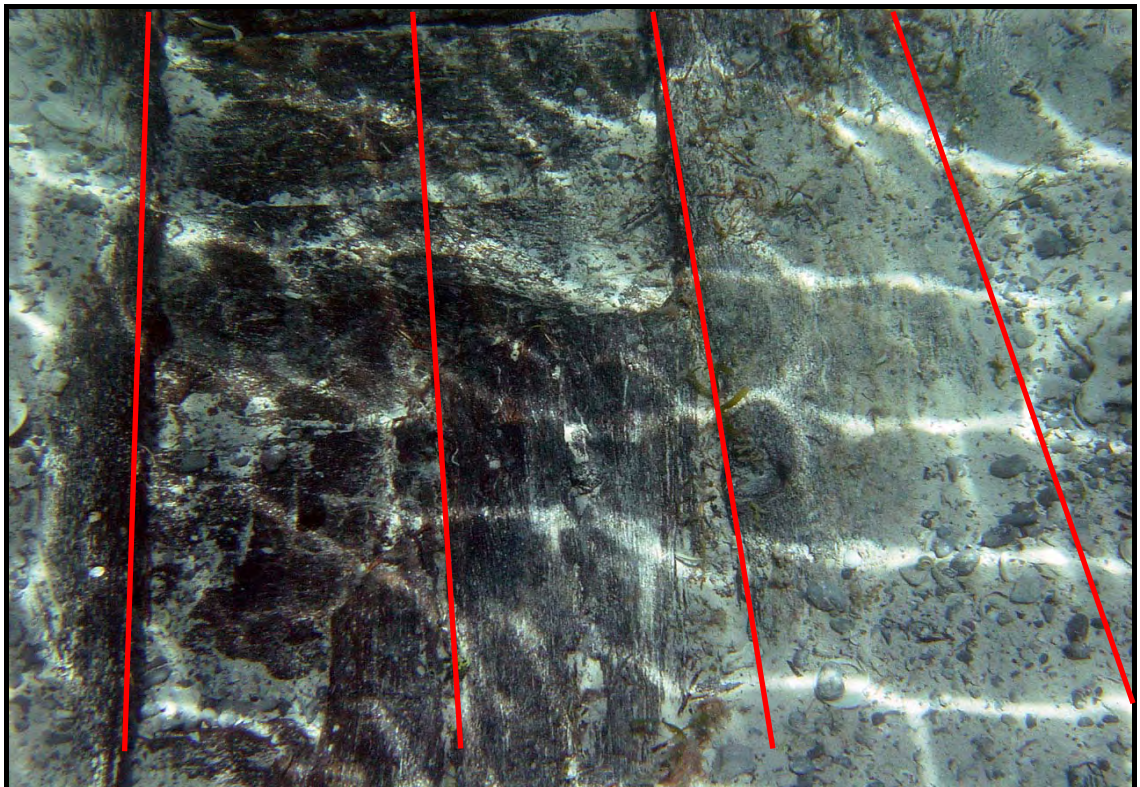
Illustration 47: Ceiling planking on the Button Wreck. The red lines indicate the individual ceiling planks, some of which are missing (© ADMAT Archives – Spooner).

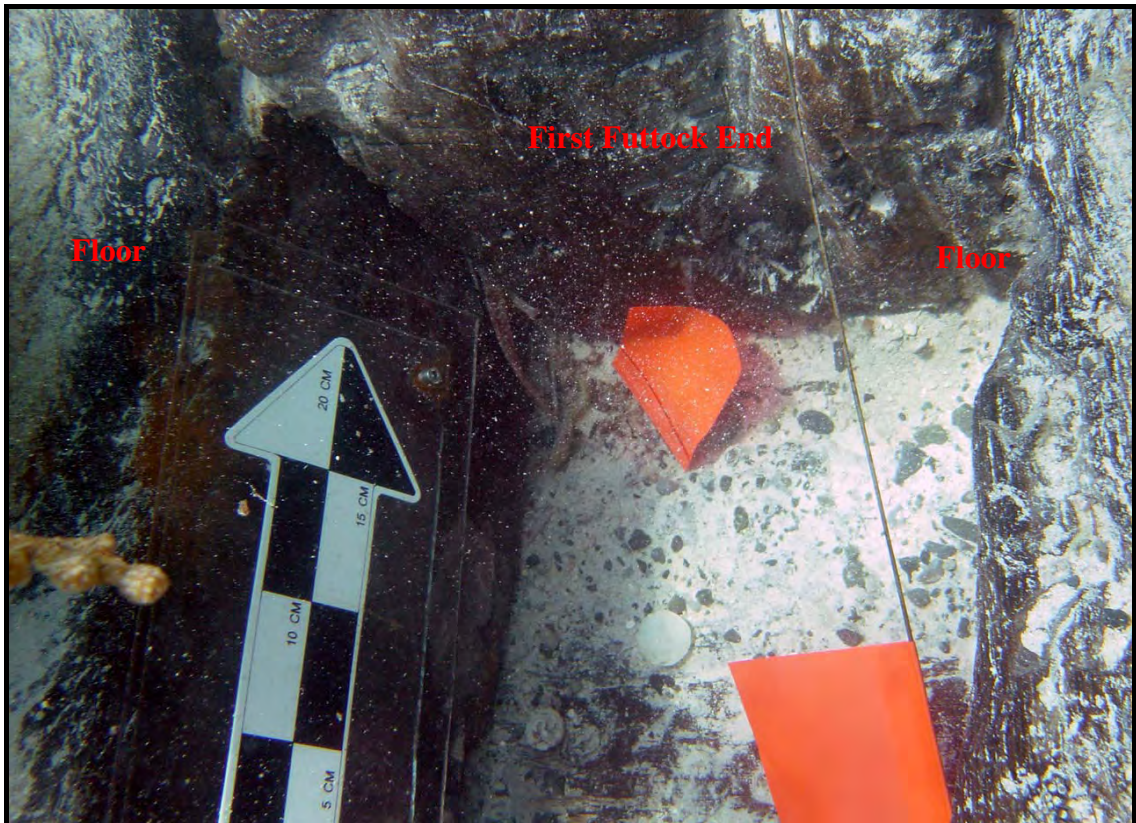
Illustration 52: The "Hole" on *The Button Wreck* caused by the two floors and the futtock ends off set as illustrated (© ADMAT Archives – Spooner).

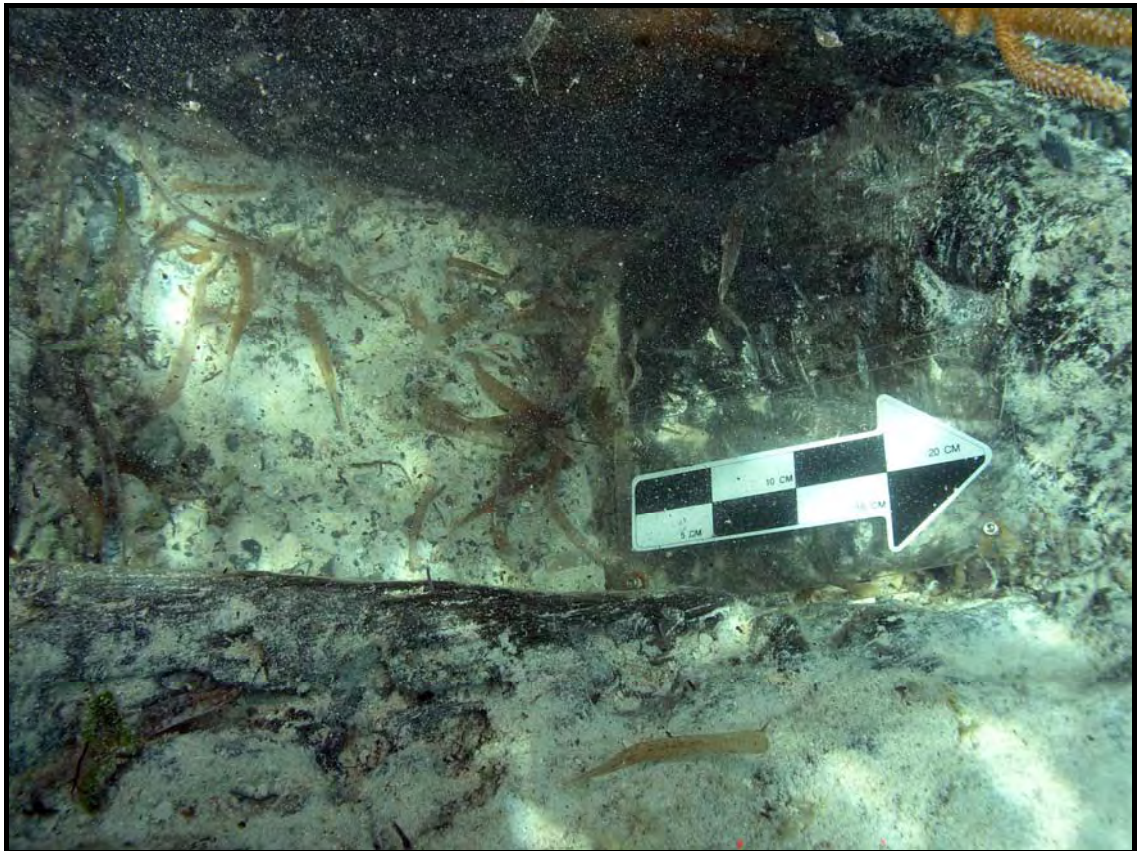
Illustration 53: Looking down into the “Hole” on *The Button Wreck* (© ADMAT Archives – Spooner).

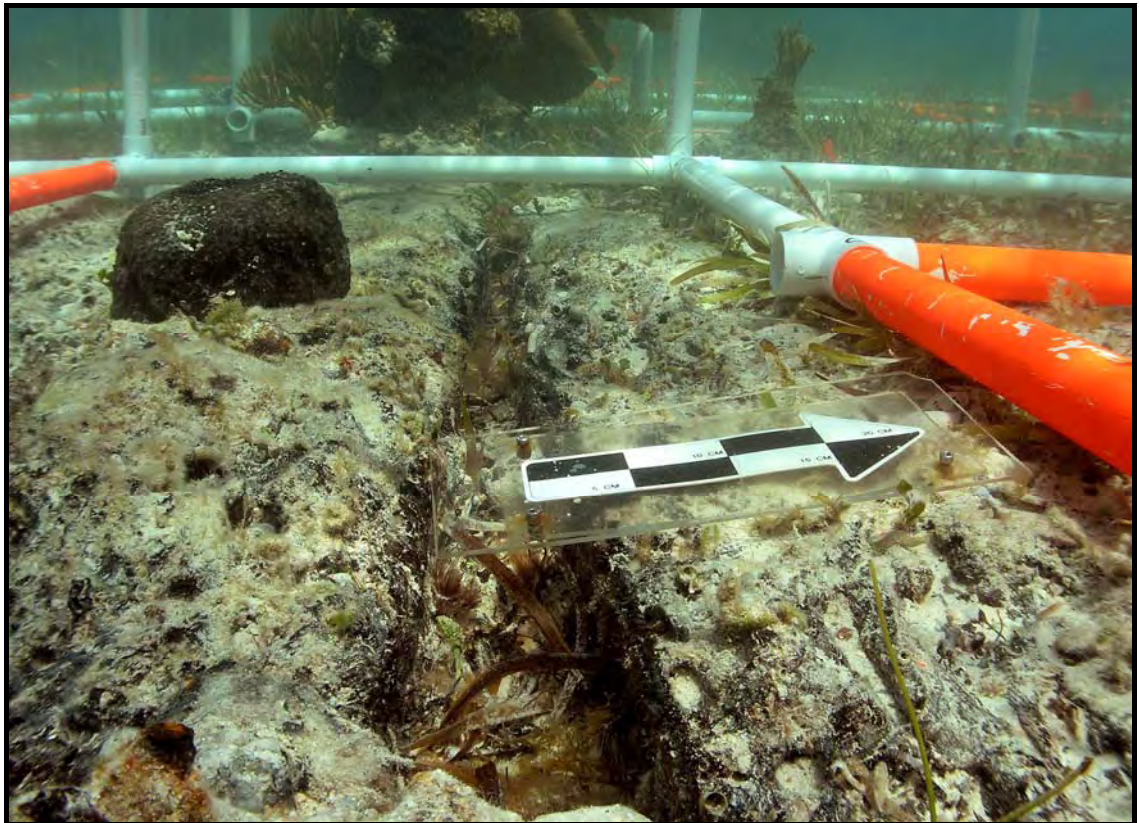
Illustration 56: The gap in Sq:C4 between the floor and first futtock, showing a typical gap (© ADMAT Archives – Shrimpton).

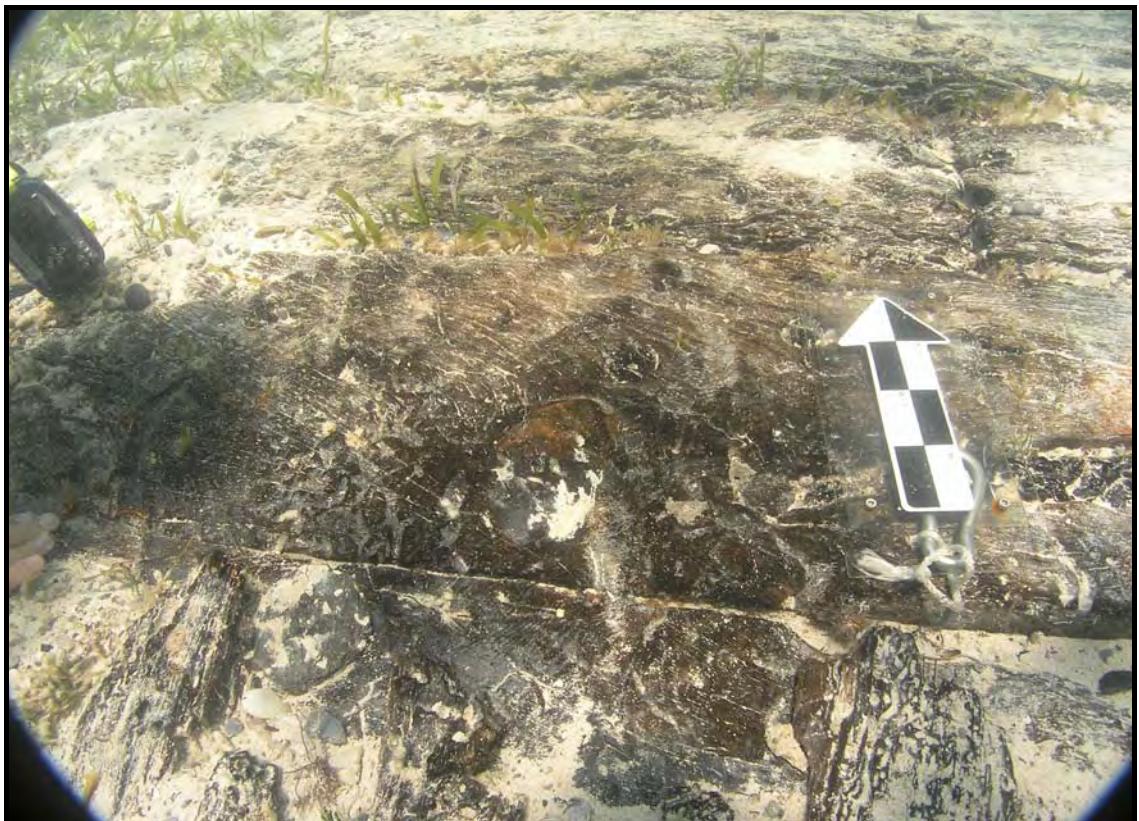
Illustration 57: The gap in Sq:B5 and C5 between the floor and first futtock, showing the possible repair and the touching timbers, which was only found between these frames (© ADMAT Archives – Shrimpton).

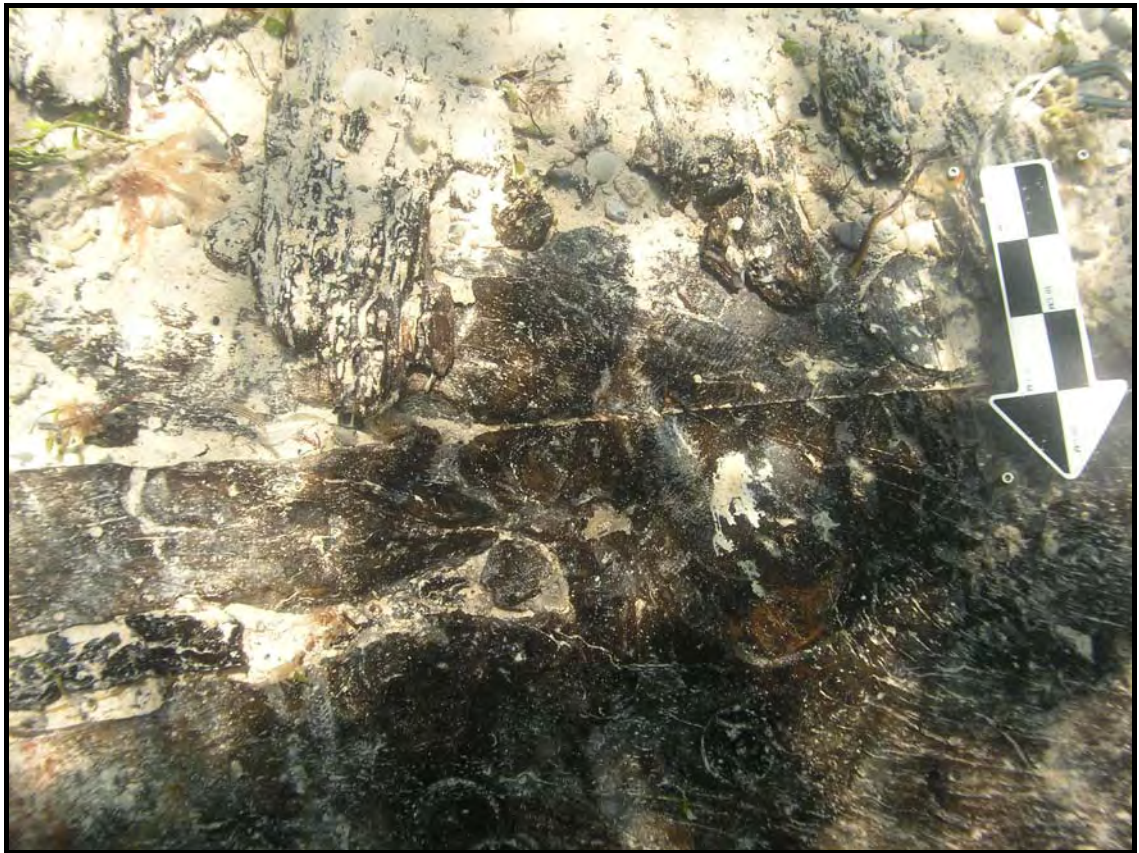
Illustration 58: The gap in Sq:B5 and C5 between the floor and first futtock, showing the possible repair and the touching timbers, which was only found between these frames, taken from a different angle (© ADMAT Archives – Shrimpton).

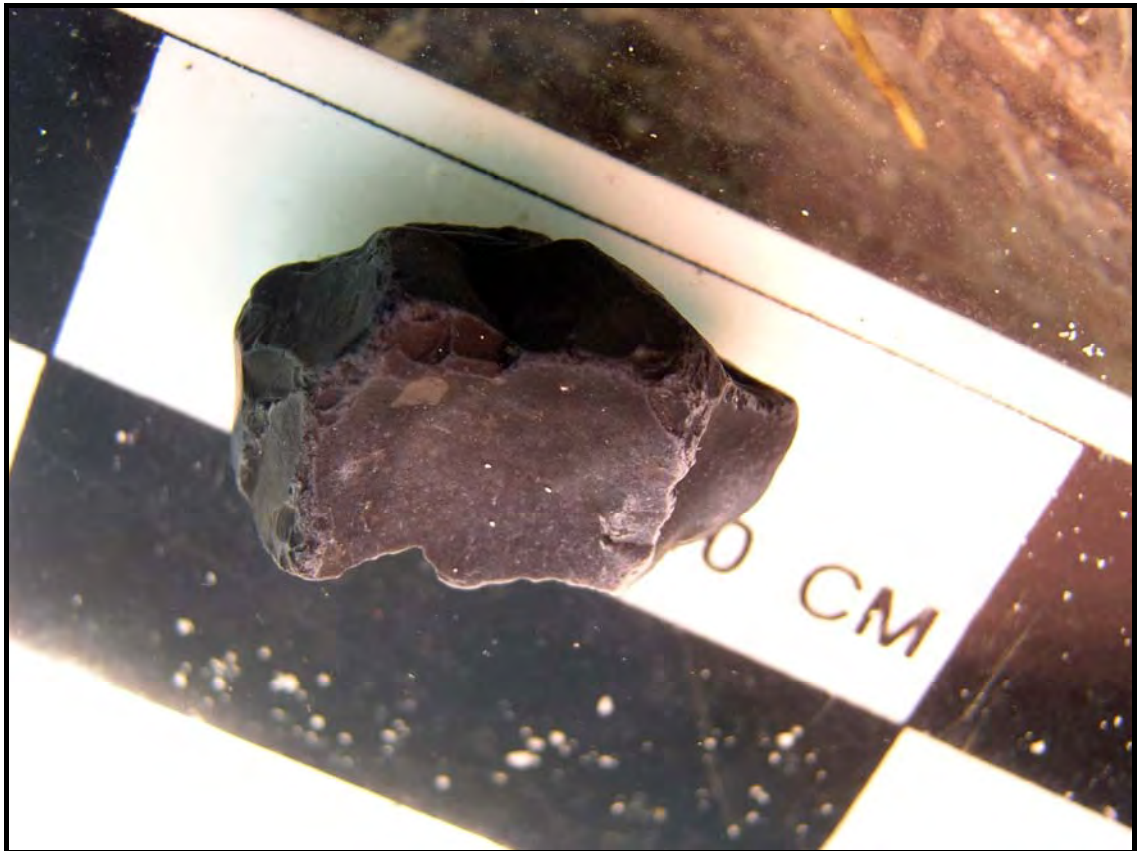
Illustration 59: one of the small ballast stones found on the central line under the keelson, on *The Button Wreck* (© ADMAT Archives – Shrimpton).

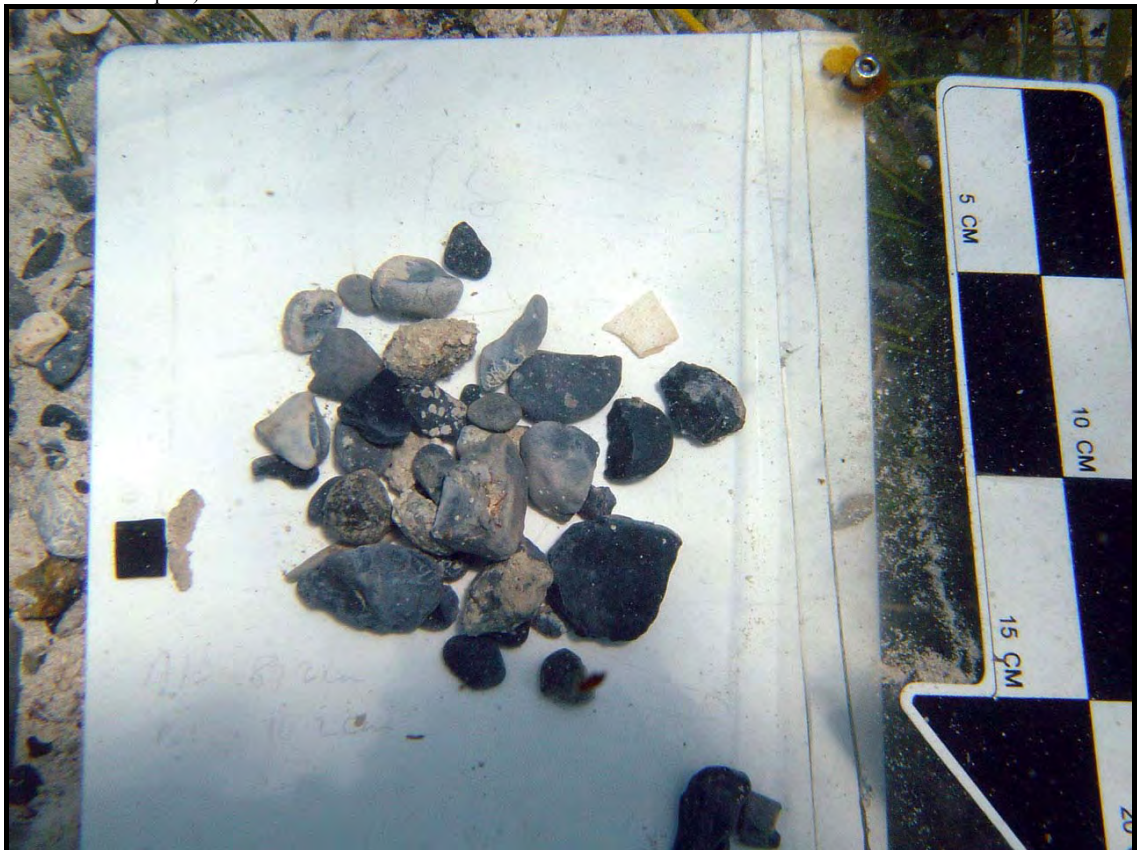
Illustration 60: A selection of ballast "Chips" found under the keelson in the futtock "Holes" on *The Button Wreck* (© ADMAT Archives – Nielsen).

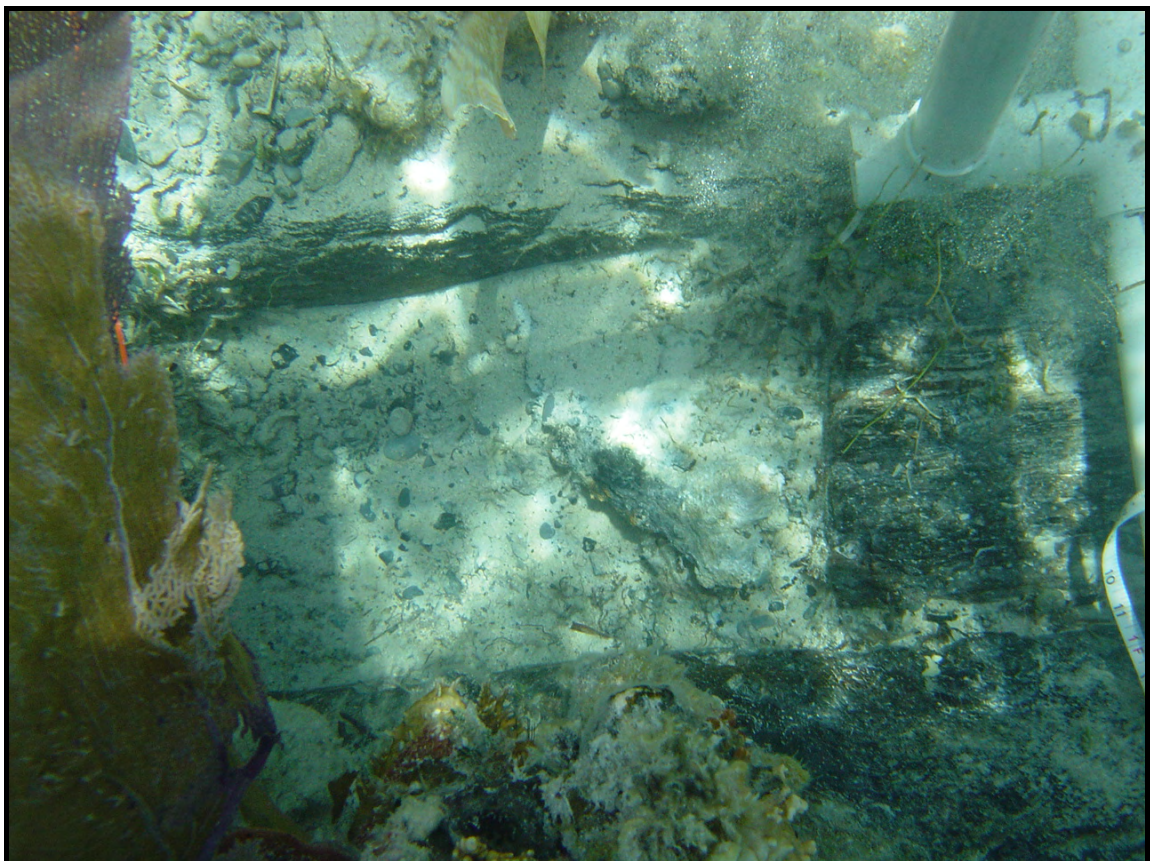
Illustration 65: The area of the hole made by the futtock ends and the sides of the floors prior to uncovering by hand fanning, on *The Button Wreck* (© ADMAT Archives - Spooner).

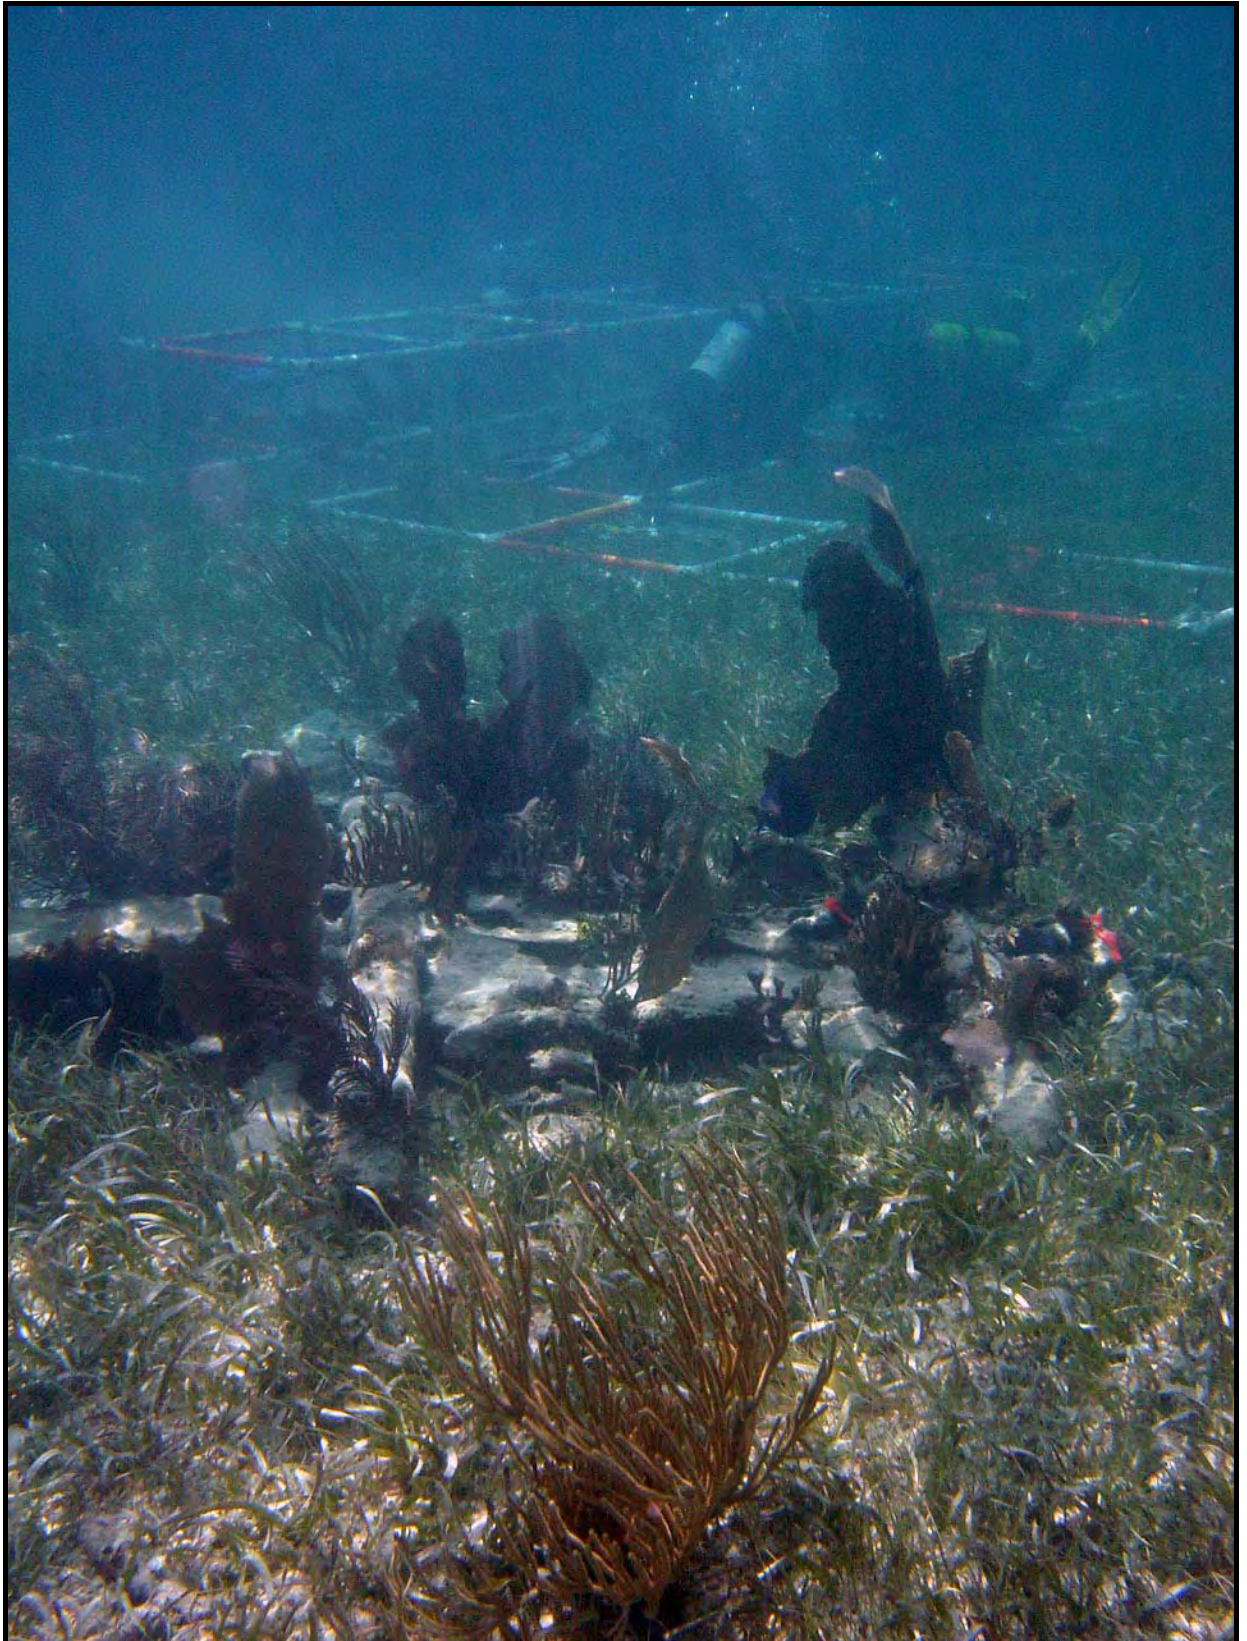
Illustration 70: The Gudgeons with *The Button Wreck* grid in the distance (© ADMAT Archives - Spooner).

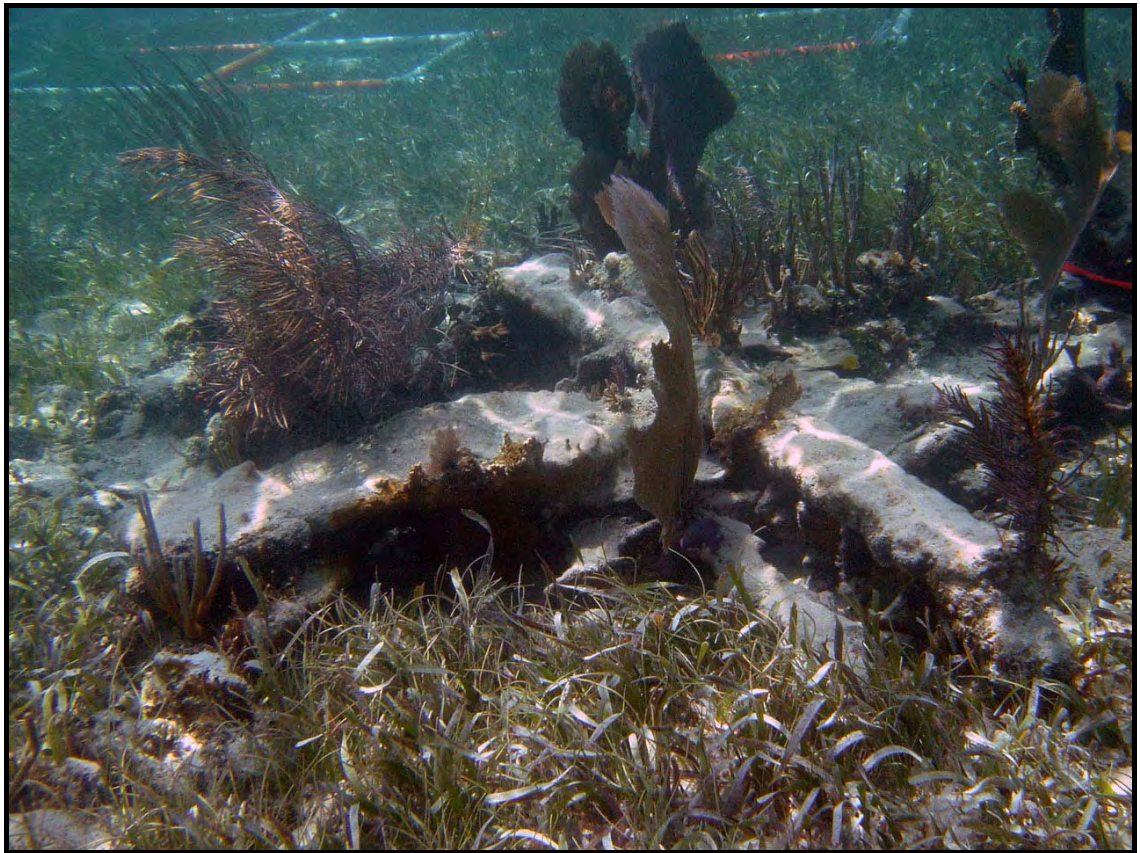
Illustration 71: Close up of the east gudgeon and the concreted iron box which possibly connected the missing gudgeons (© ADMAT Archives - Nielsen).

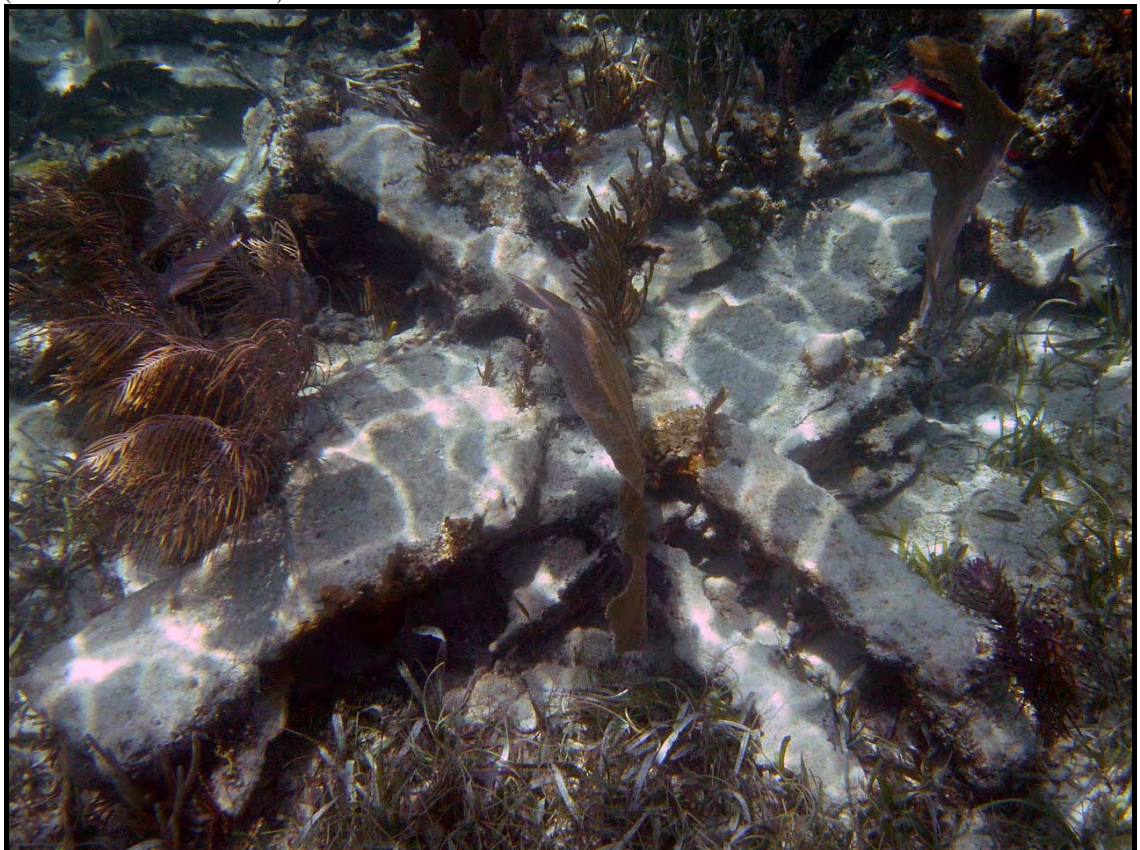
Illustration 72: Close up of the east gudgeon and the concreted iron box which possibly connected the missing gudgeons (© ADMAT Archives - Nielsen).
