A . D . M . A . T .

Anglo ~ Danish Maritime Archaeological Team

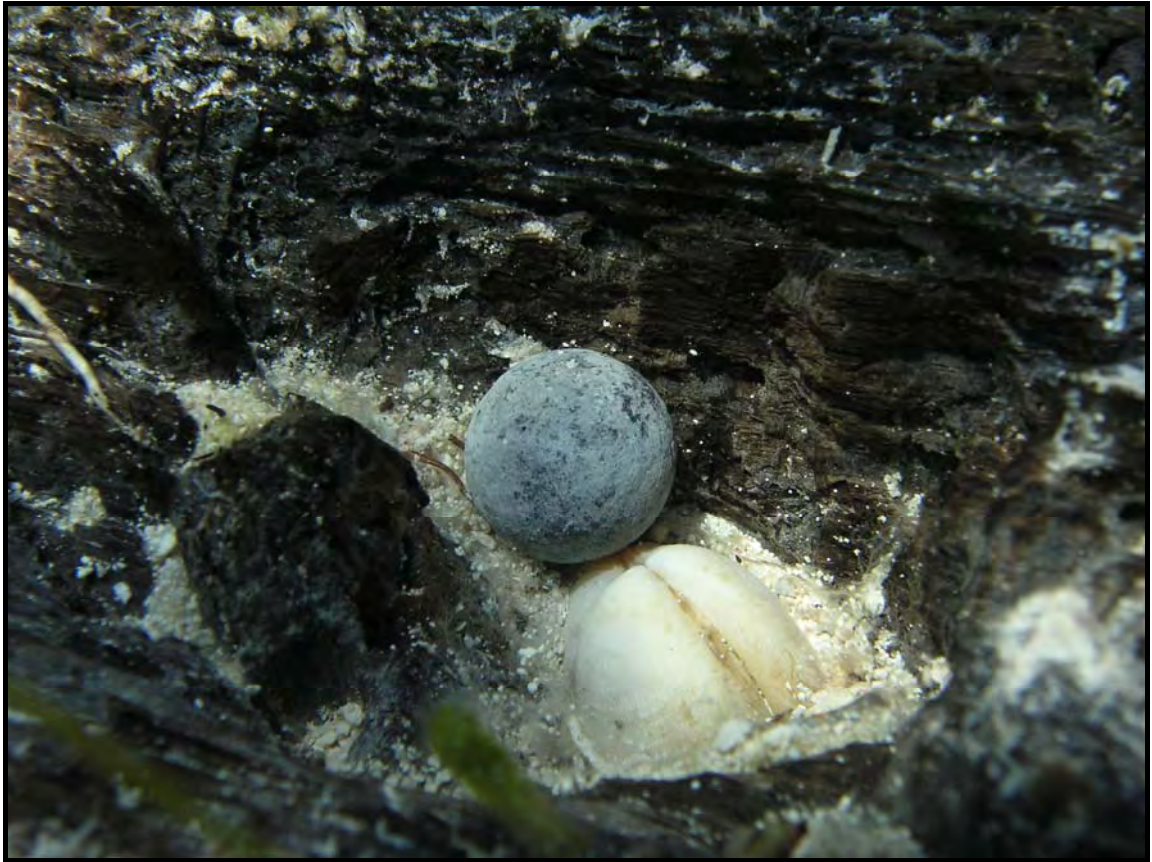
Illustration 82: The musket ball, artefact No: BW/2005/Or/S/003 found on *The Button Wreck*, photographed in situ (© ADMAT Archives - Spooner).

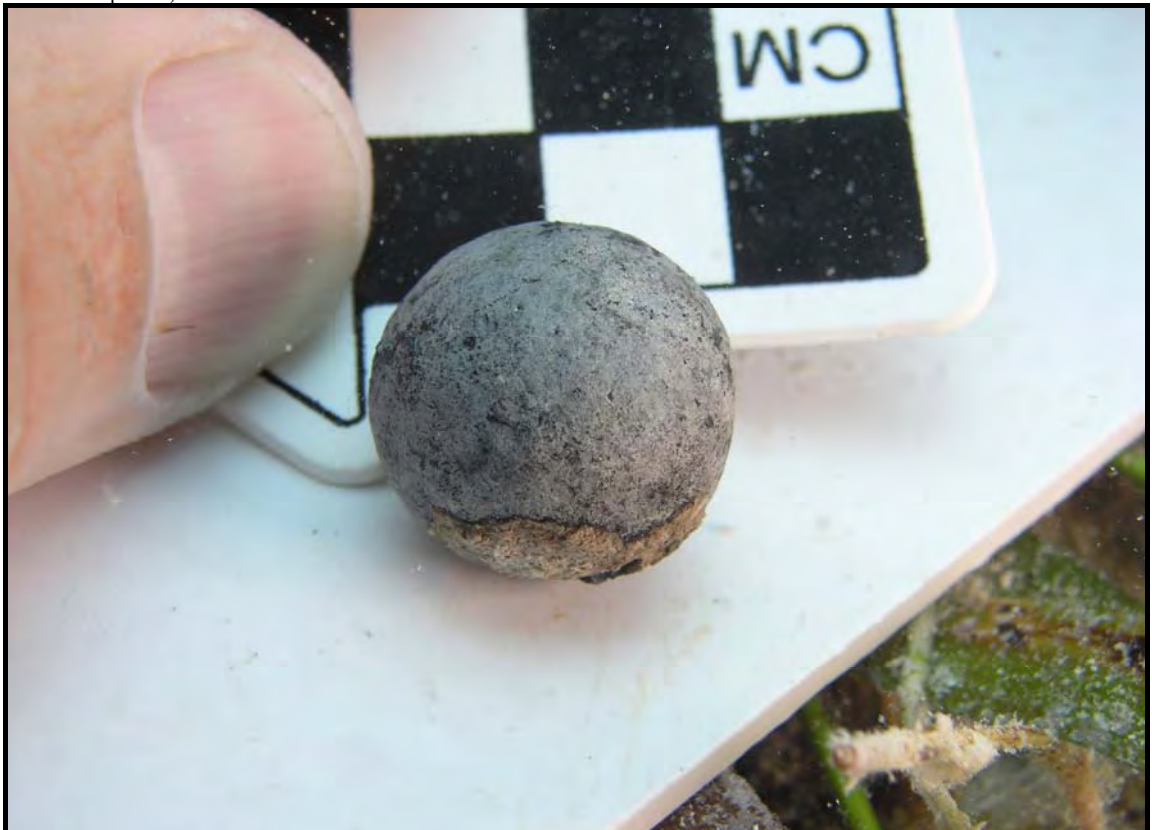
Illustration 83: The musket ball, artefact No: BW/2005/Or/S/003, underwater close up which was found on *The Button Wreck*, photographed in situ (© ADMAT Archives - Spooner).

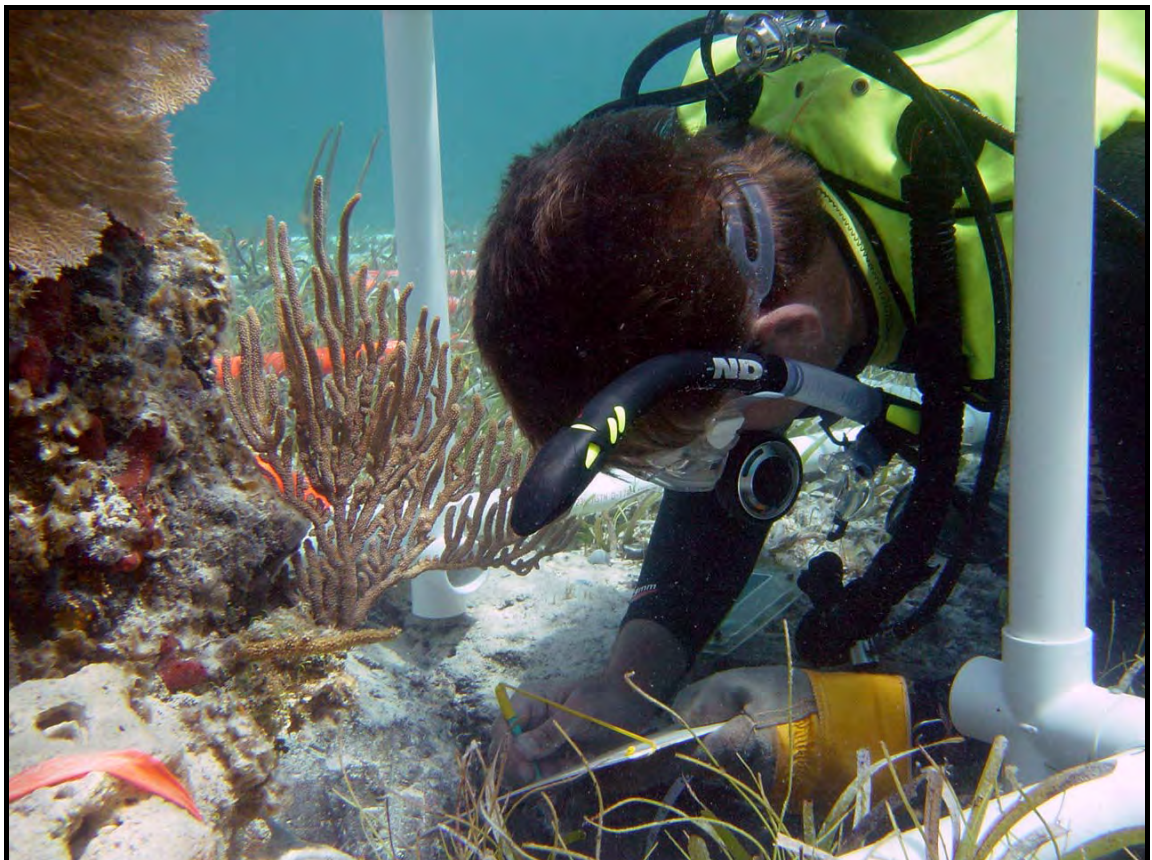
Illustration 85: The Principal Investigator, Dr. Simon Q. Spooner examining and recording the silver coin on *The Button Wreck* (© ADMAT Archives - Nielsen).

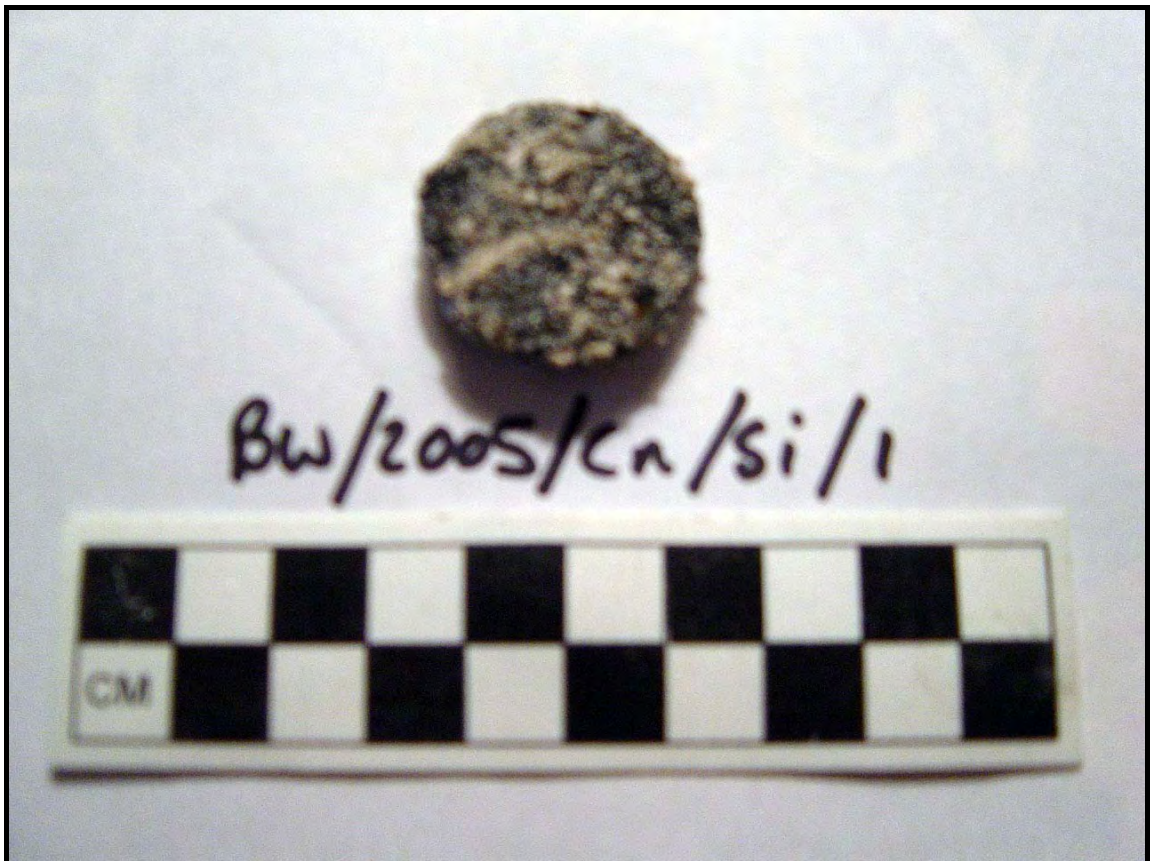
Illustration 88: An out of focus underwater photograph of the silver coin, prior to recovering and sending to NOAA (© ADMAT Archives - Nielsen).

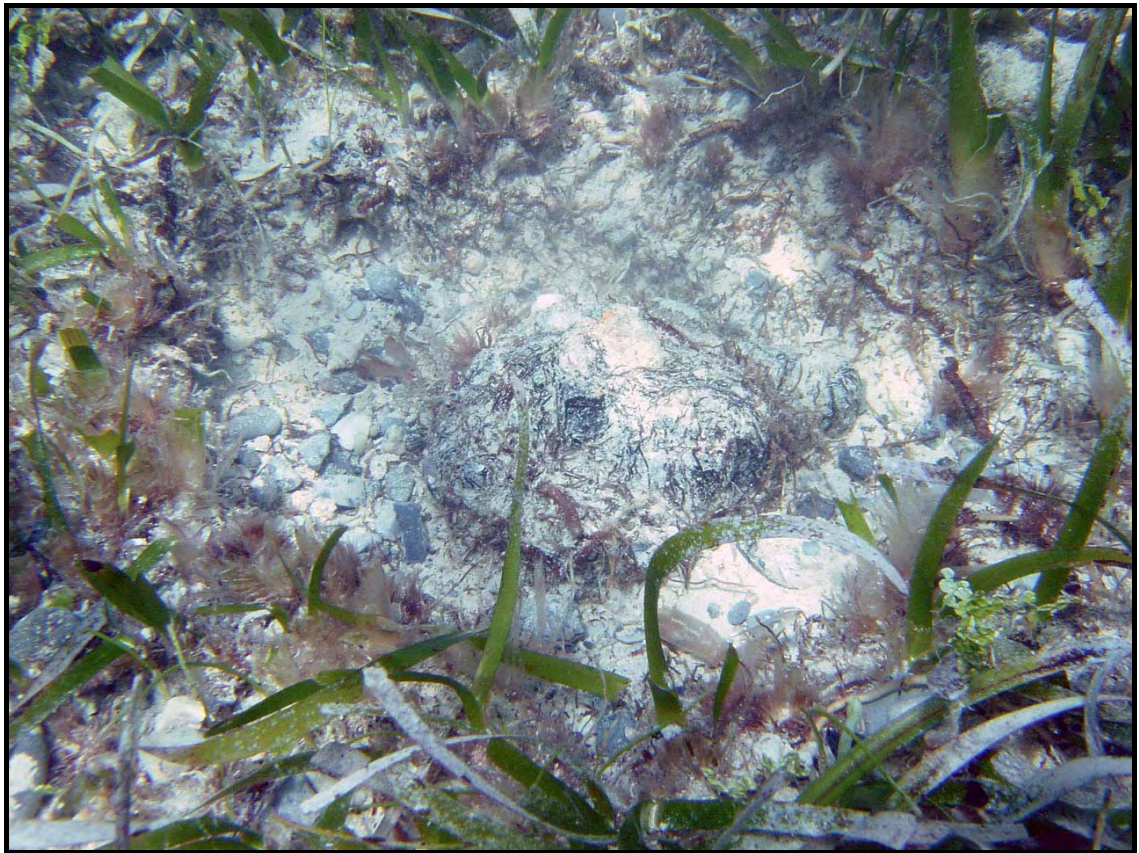
Illustration 90: The cannon ball in situ on *The Button Wreck* (© ADMAT Archives - Spooner).

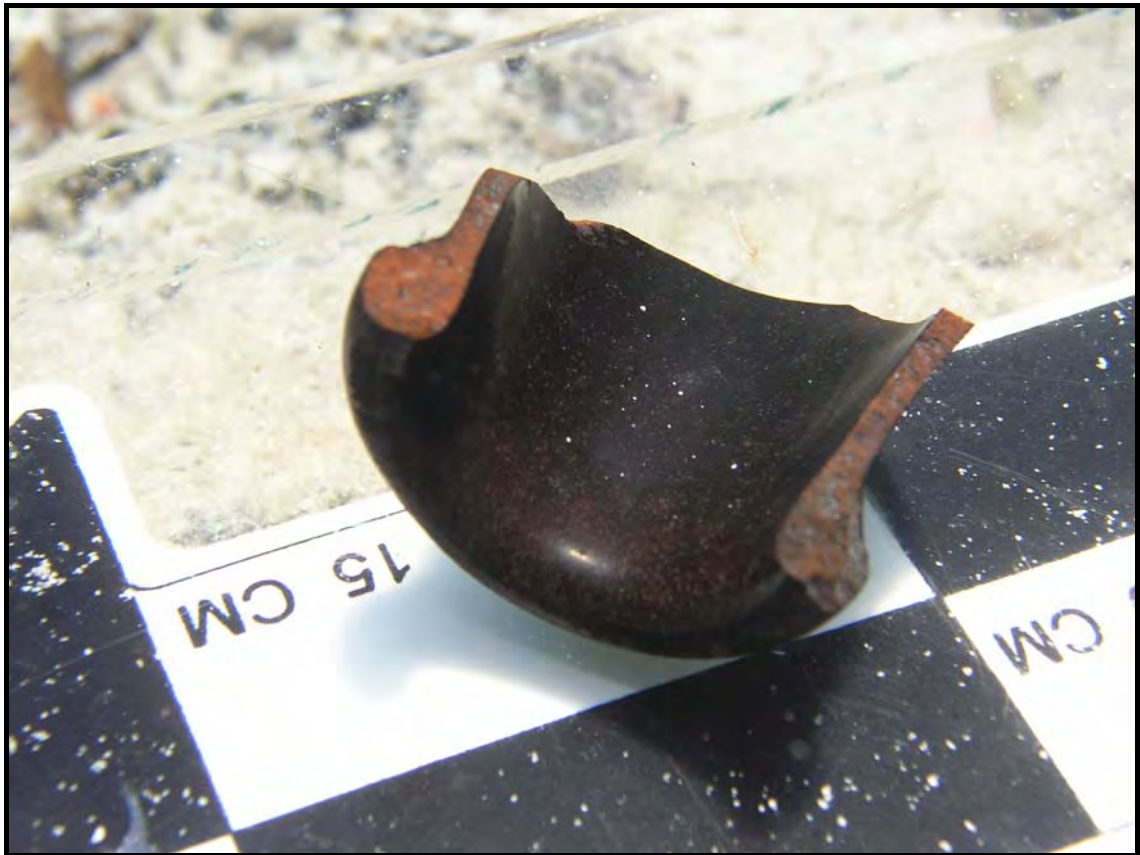
Illustration 91: The brown glazes bottle neck found on The Button Wreck (© ADMAT Archives - Nielsen).

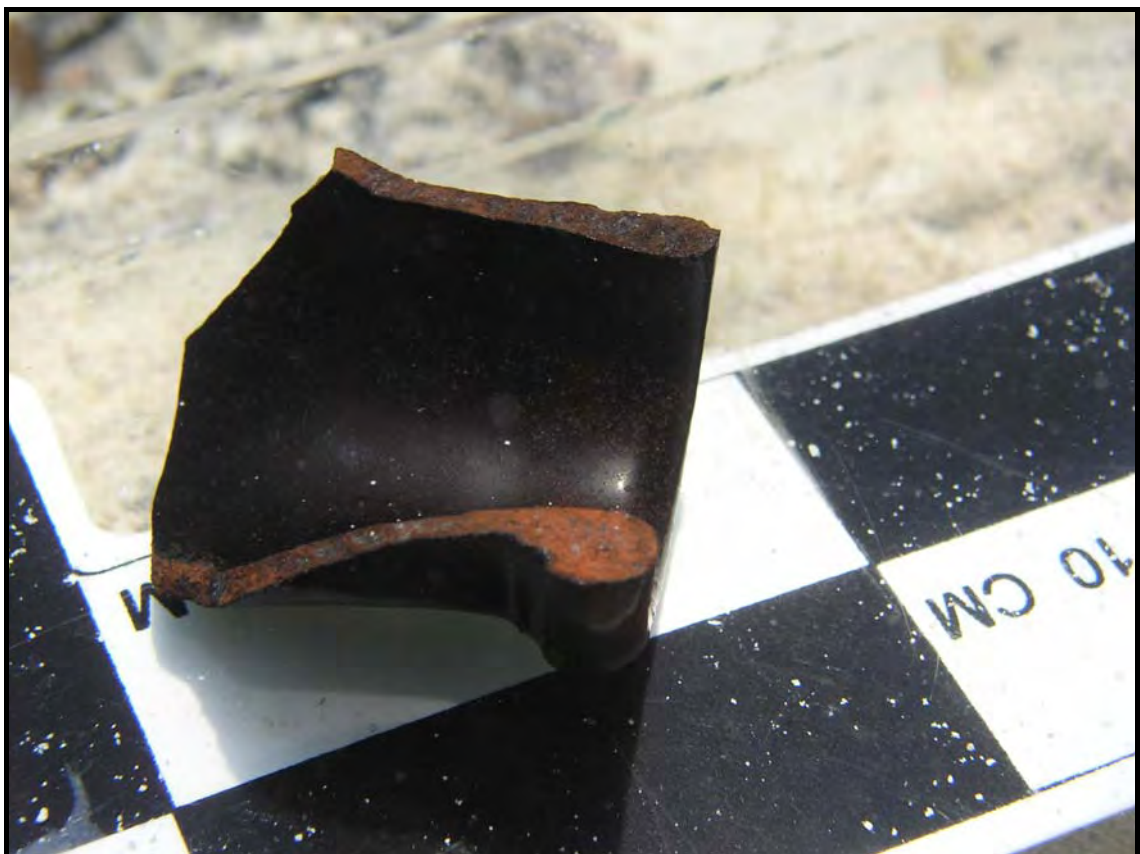
Illustration 92: The brown glazes bottle neck found on The Button Wreck (© ADMAT Archives - Nielsen).

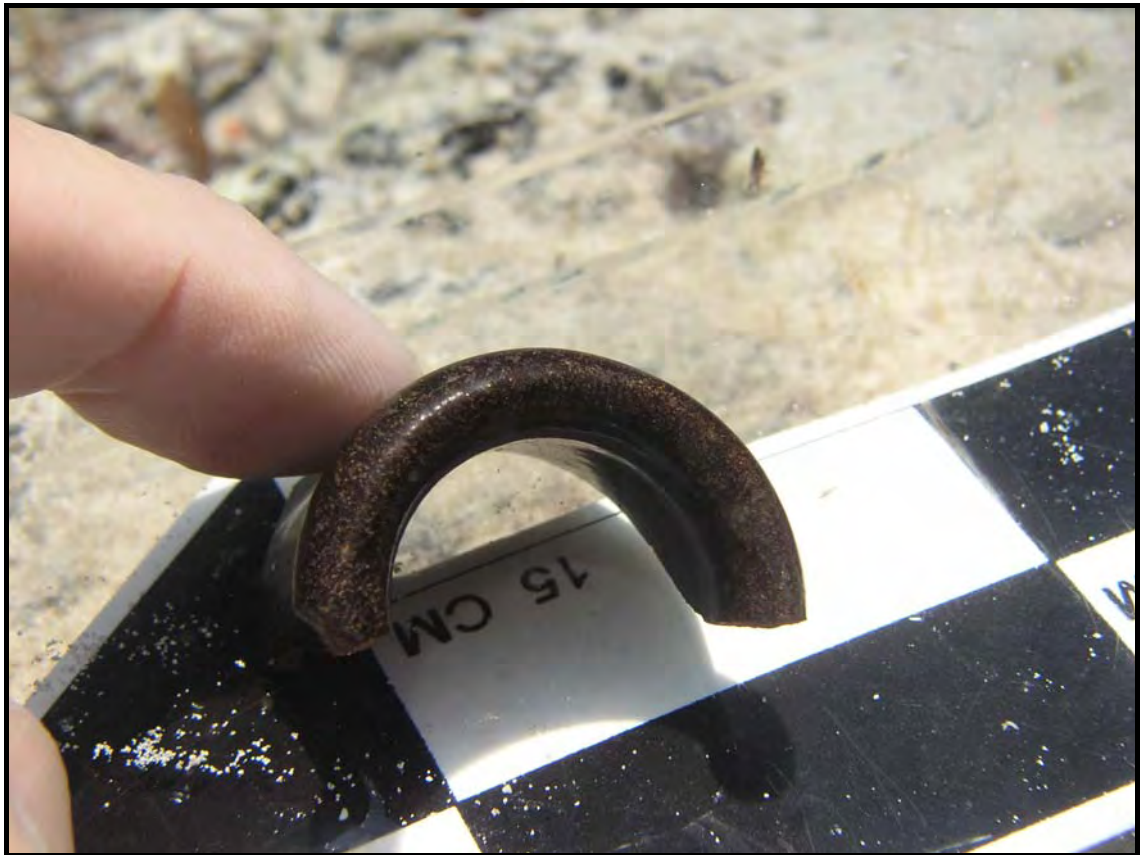
Illustration 93: The brown glazes bottle neck found on The Button Wreck (© ADMAT Archives - Nielsen).

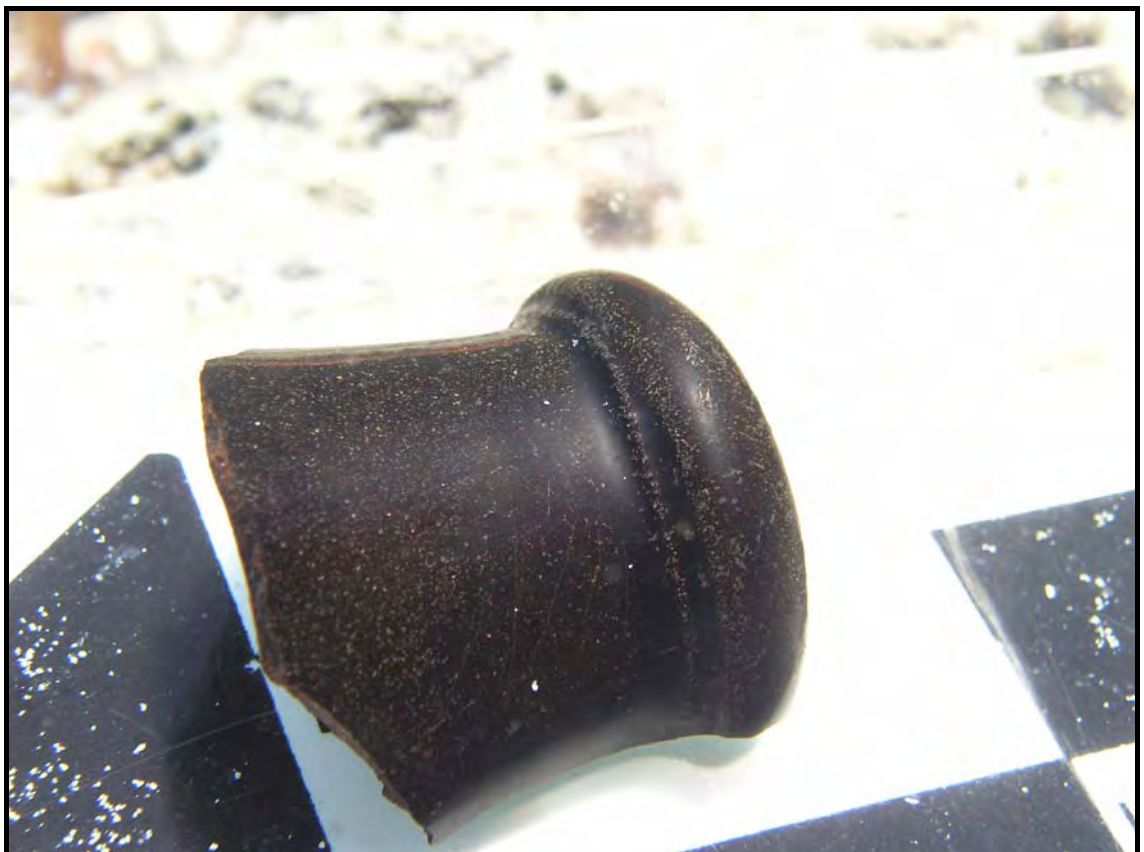
Illustration 94: The brown glazes bottle neck found on The Button Wreck (© ADMAT Archives - Nielsen).

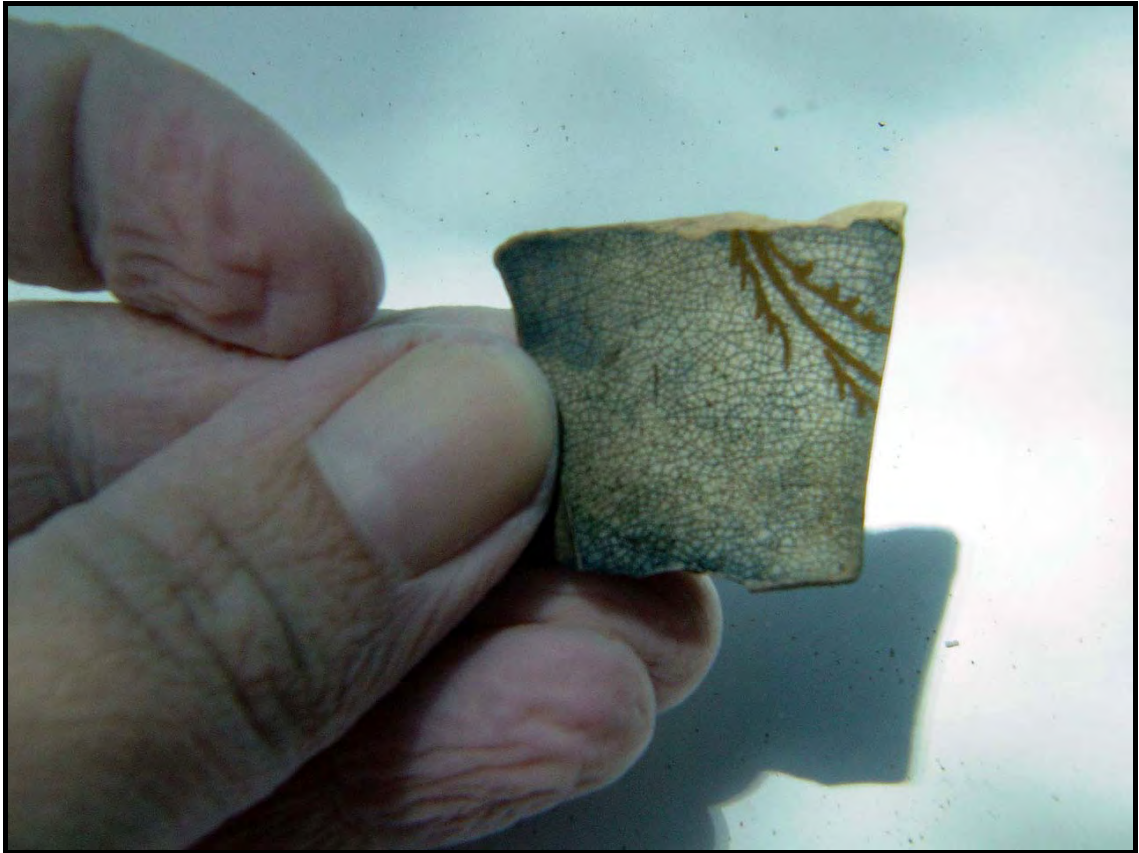
Illustration 95: The second sherd found on The Button Wreck, photographed underwater (© ADMAT Archives - Nielsen).

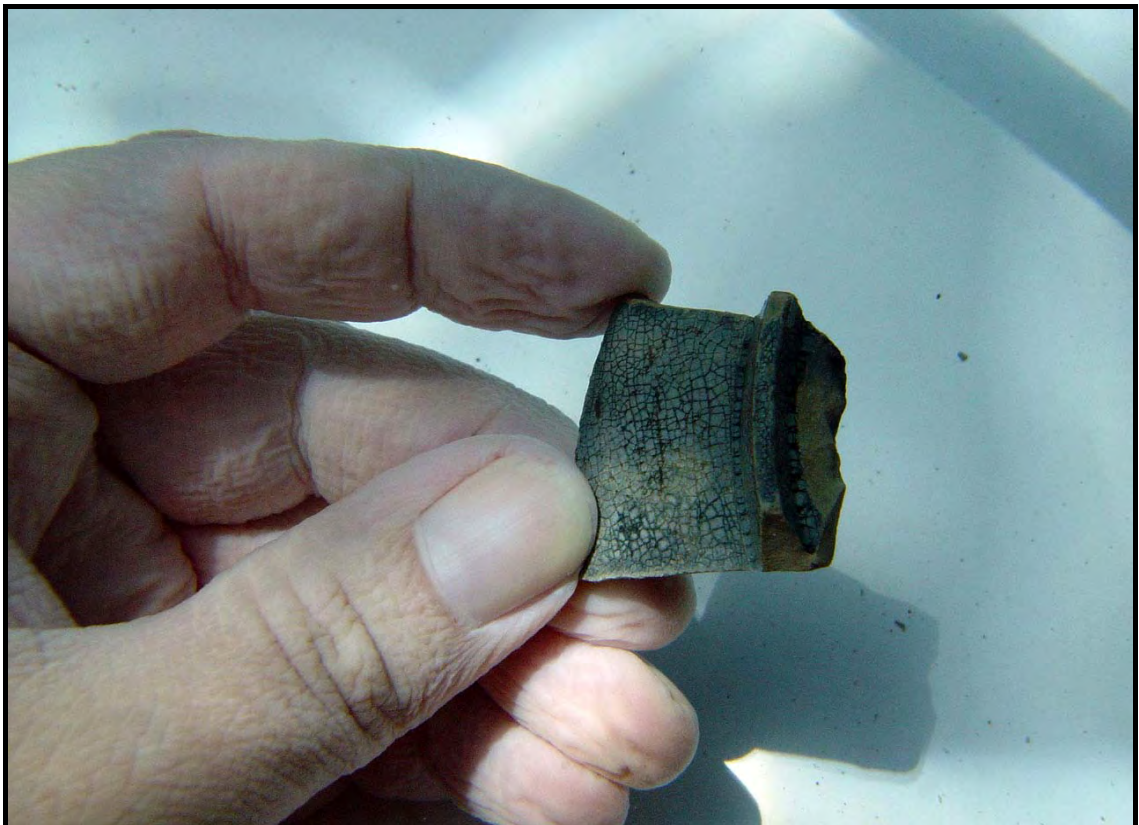
Illustration 96: The underside of the base rim sherd found on The Button Wreck (© ADMAT Archives - Nielsen).

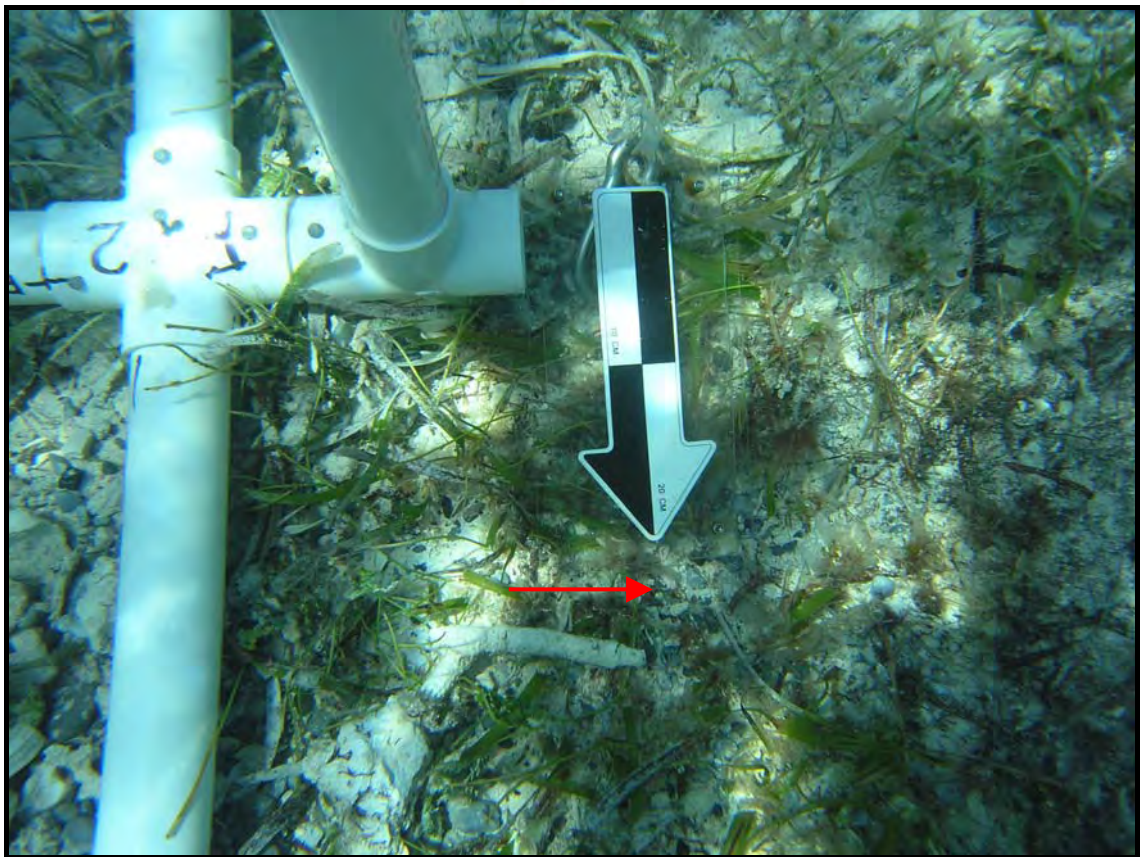
Illustration 97: Artefact BW/2005/NF/Pb/005, a white metal which was after conservation confirmed as a pewter button found on *The Button Wreck*, shown by red arrow (© ADMAT Archives - Spooner).

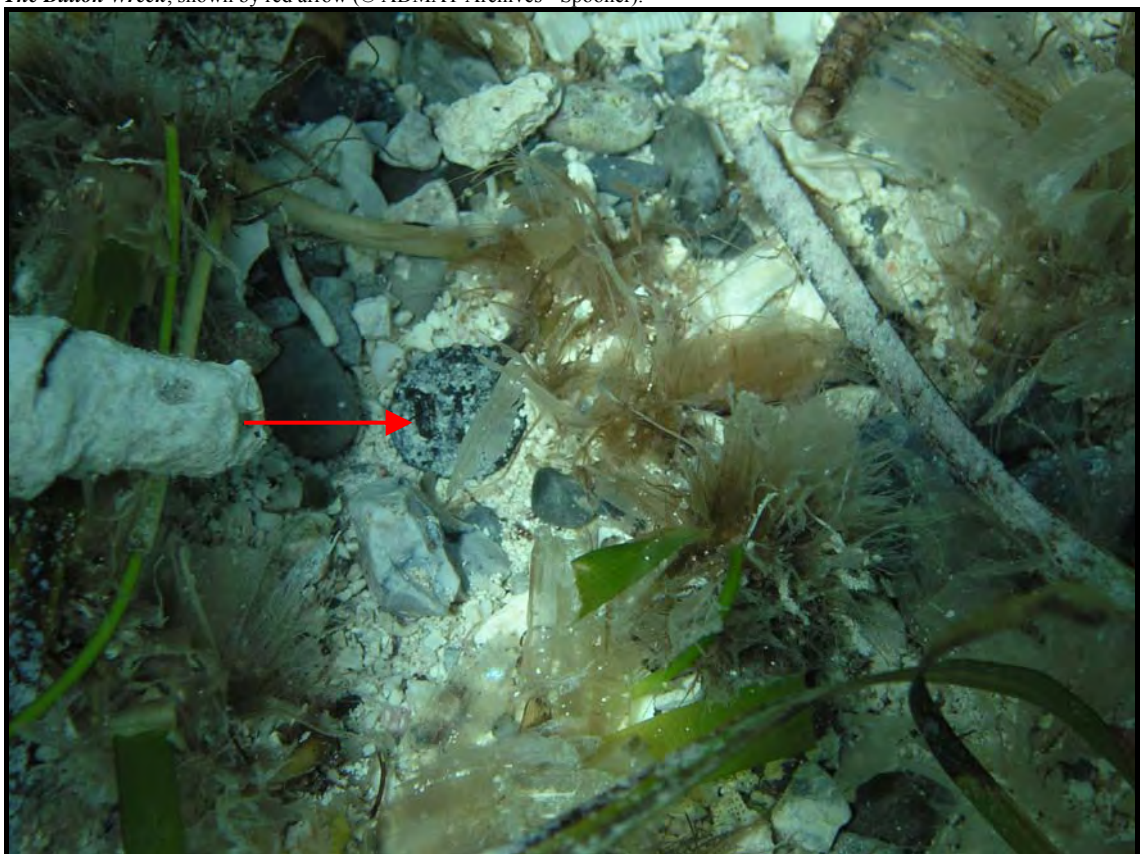
Illustration 98: Artefact BW/2005/NF/Pb/005, a white metal which was after conservation confirmed as a pewter button found on *The Button Wreck*, shown by red arrow (© ADMAT Archives - Spooner).

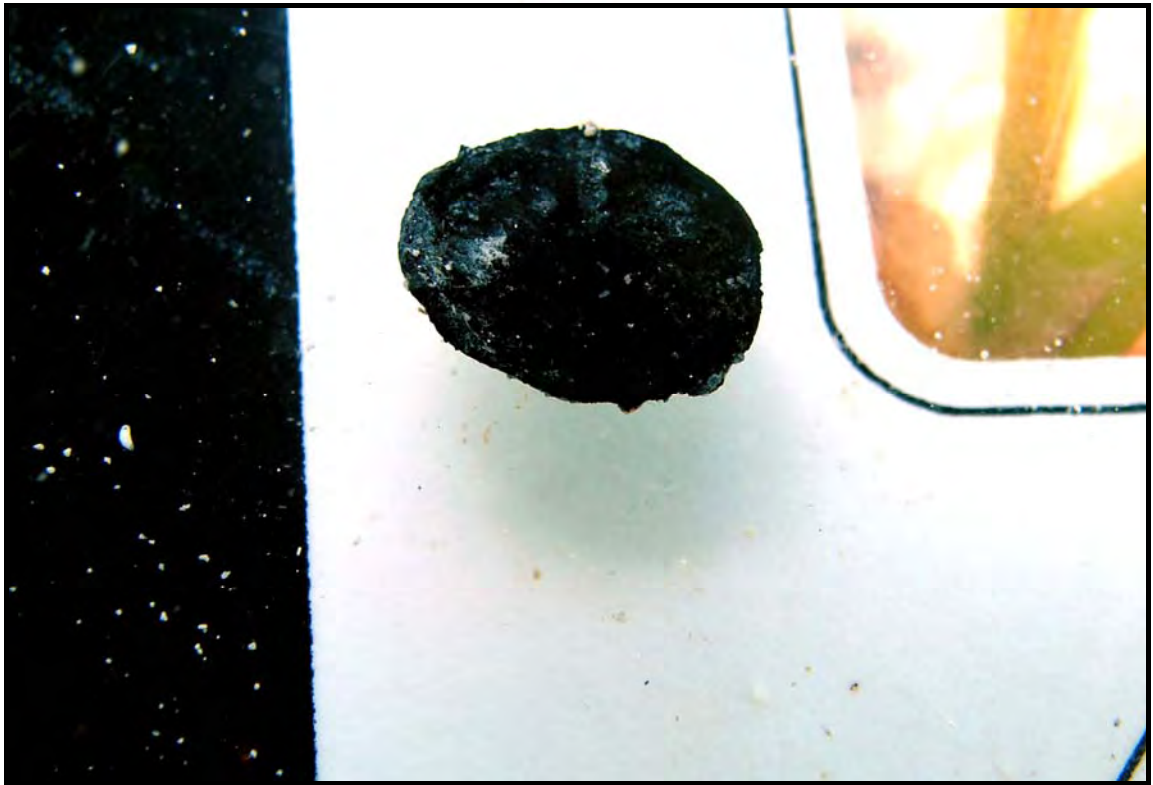
Illustration 99: Artefact BW/2005/NF/Pb/005, a white metal which was after conservation confirmed as a pewter button found on *The Button Wreck* (© ADMAT Archives - Spooner).

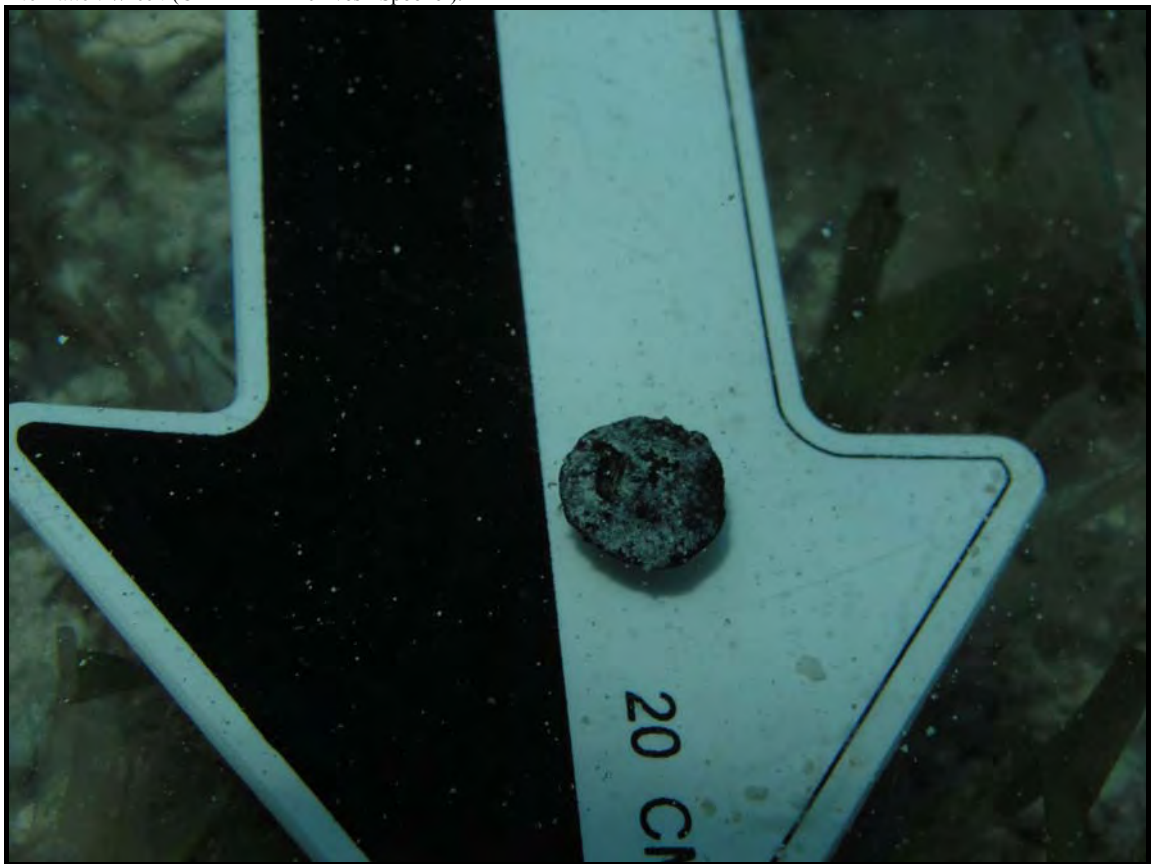
Illustration 100: Artefact BW/2005/NF/Pb/006, a white metal which was after conservation confirmed as a pewter button found on *The Button Wreck*, shown by red arrow (© ADMAT Archives - Spooner).

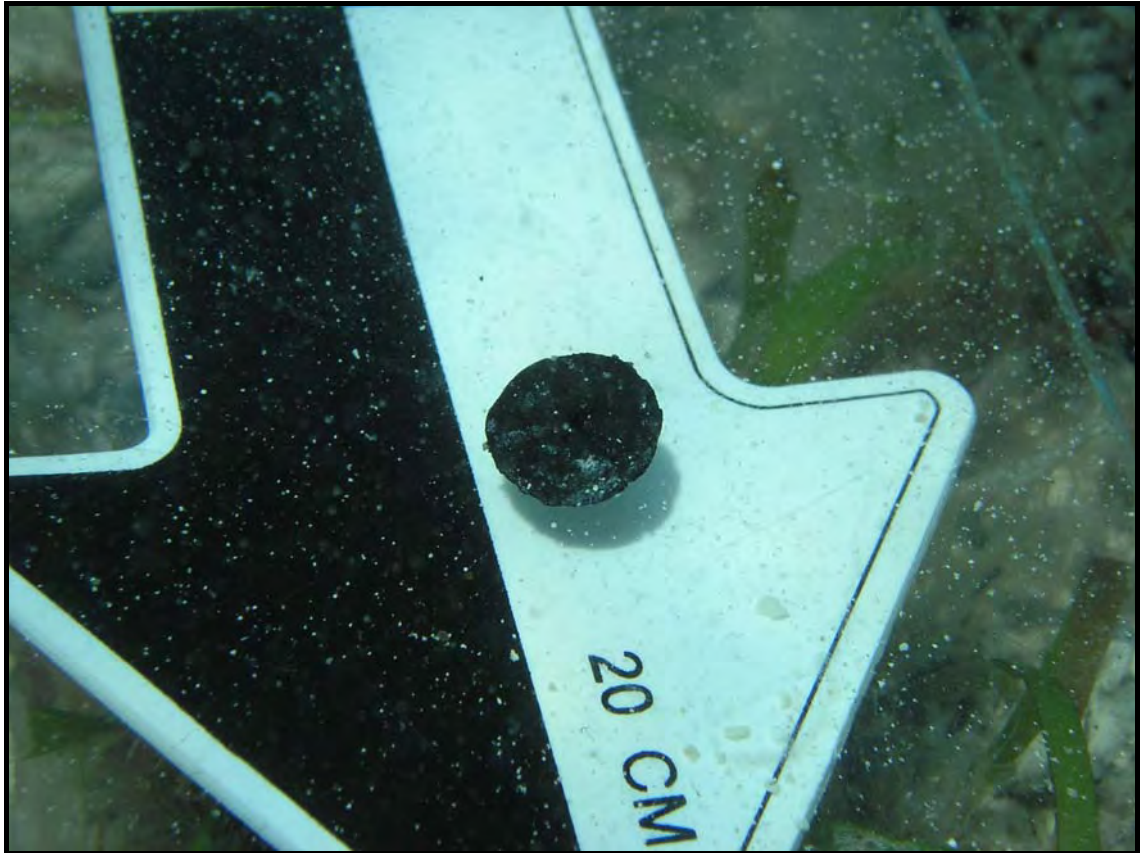
Illustration 101: Artefact BW/2005/NF/Pb/006, a white metal which was after conservation confirmed as a pewter button found on *The Button Wreck*, shown by red arrow (© ADMAT Archives - Spooner).

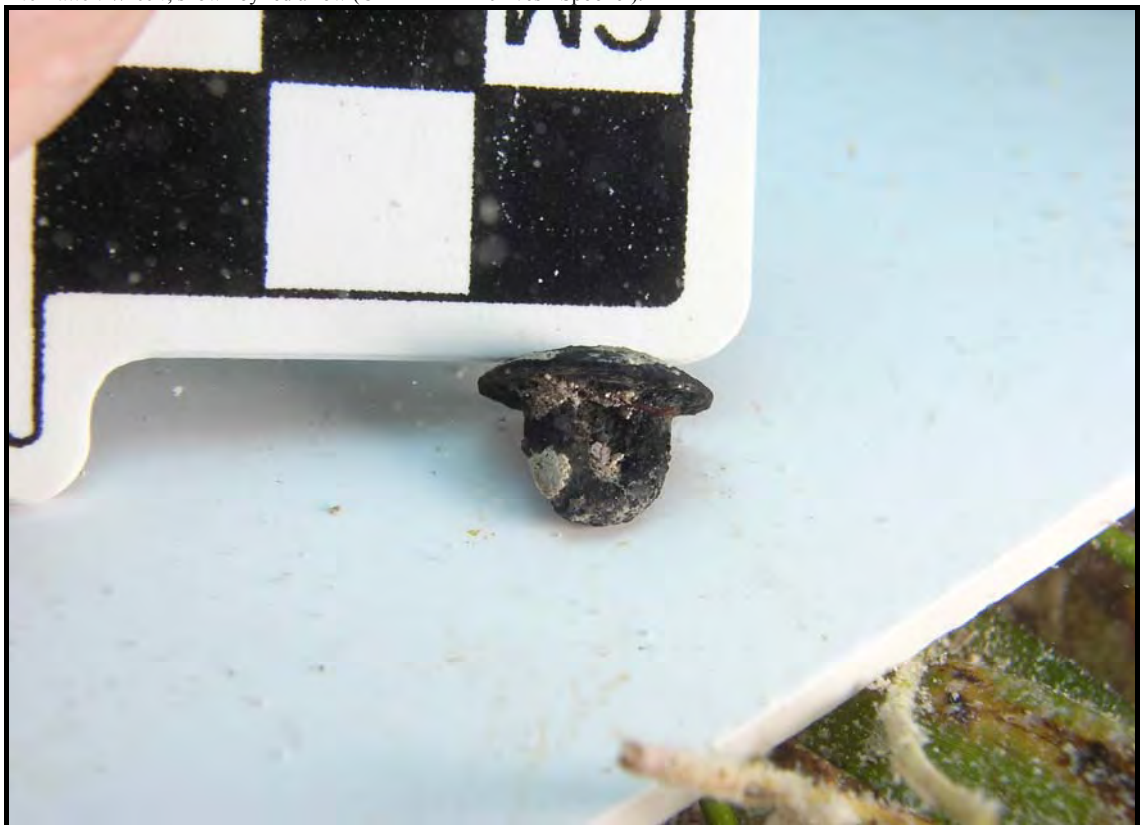
Illustration 102: Artefact BW/2005/NF/Pb/007, a white metal which was after conservation confirmed as a pewter button found on *The Button Wreck*, possibly a spat button (© ADMAT Archives - Spooner).

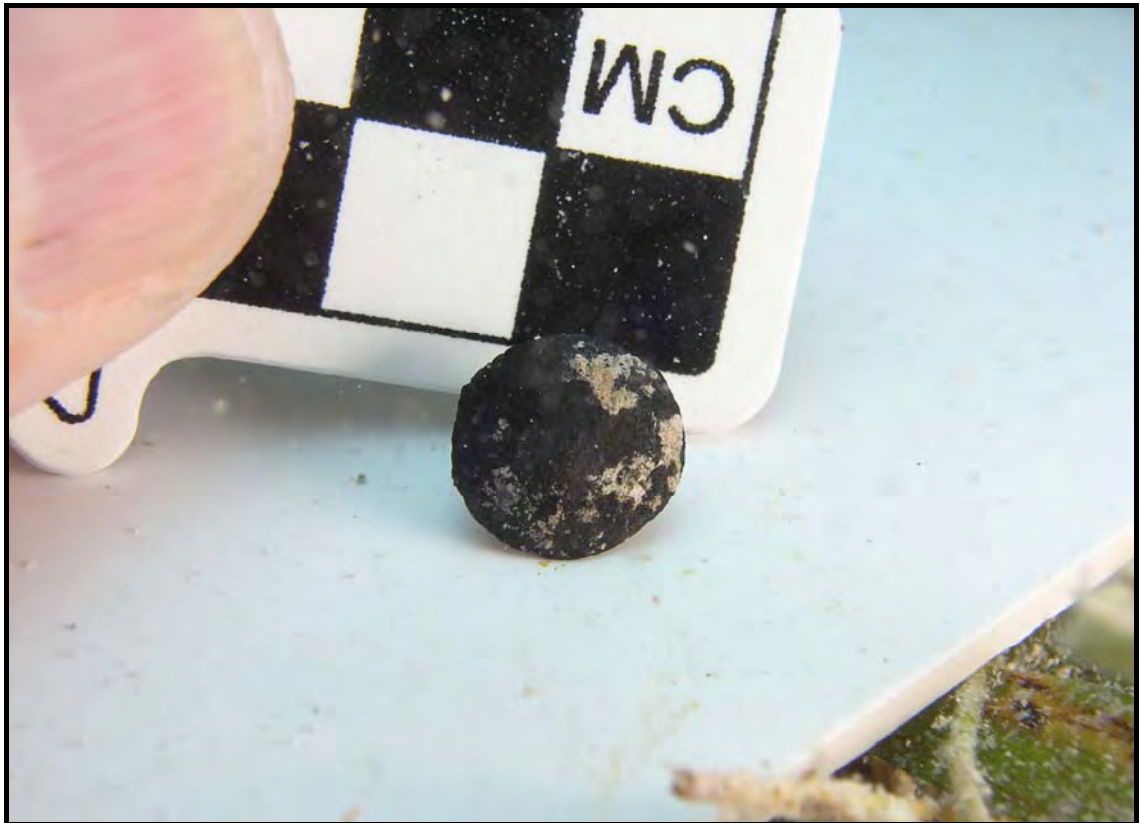
Illustration 103: Artefact BW/2005/NF/Pb/007, a white metal which was after conservation confirmed as a pewter button found on *The Button Wreck* (© ADMAT Archives - Spooner).

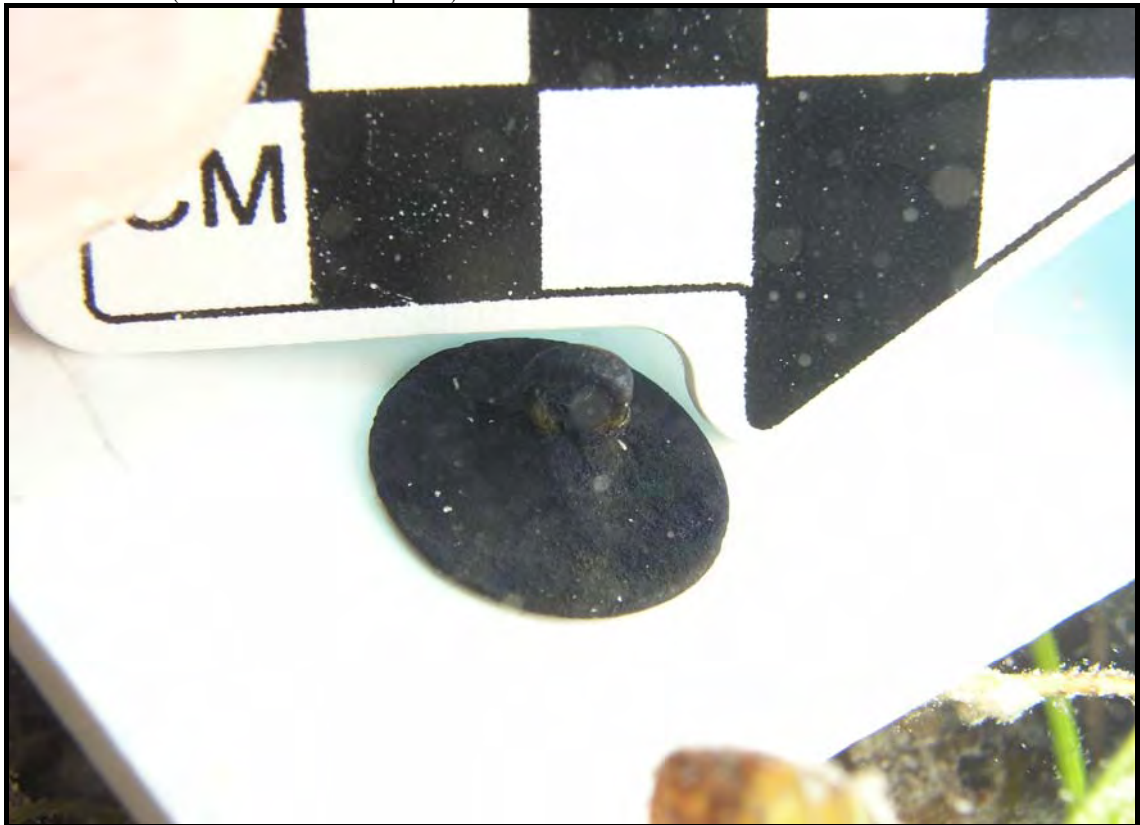
Illustration 104: Artefact BW/2005/NF/Pb/008, a copper alloy which was after conservation confirmed as a brass button found on *The Button Wreck*, (© ADMAT Archives - Spooner).

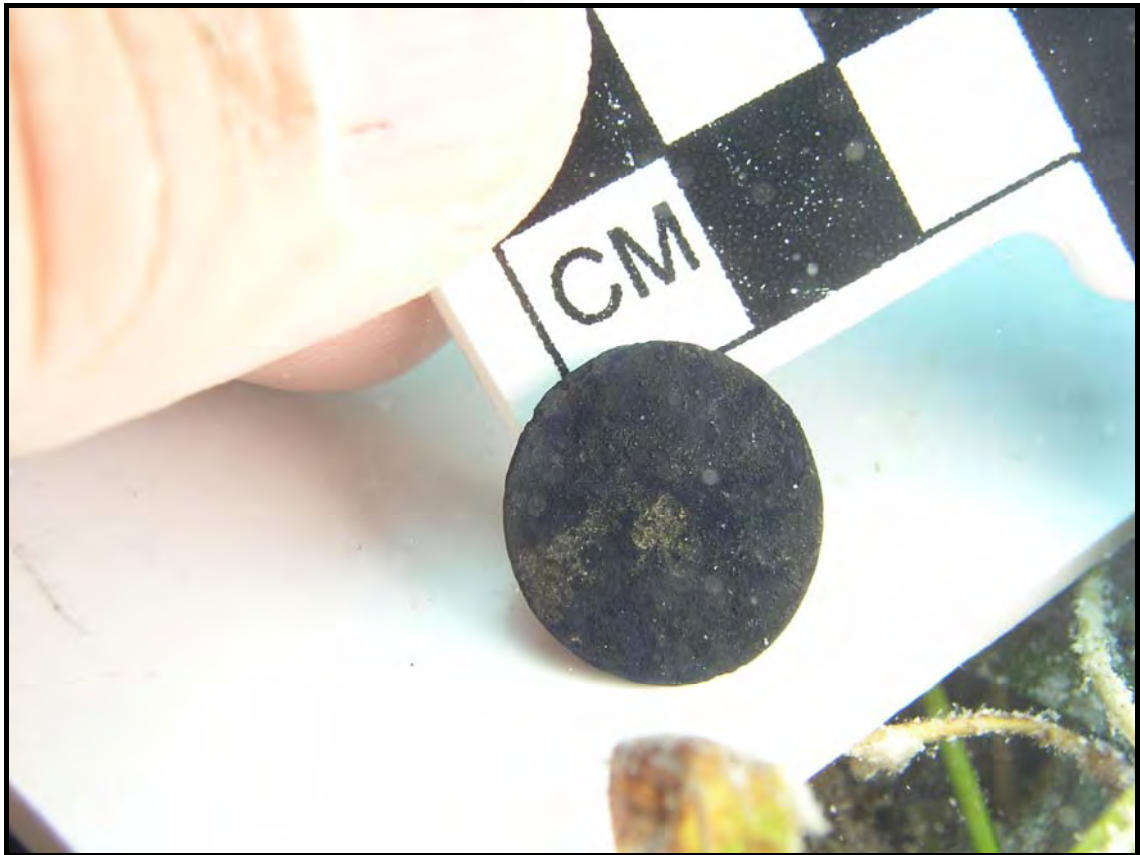
Illustration 105: Artefact BW/2005/NF/Pb/008, copper alloy which was after conservation confirmed as a brass button found on *The Button Wreck*, shown by red arrow (© ADMAT Archives - Spooner).

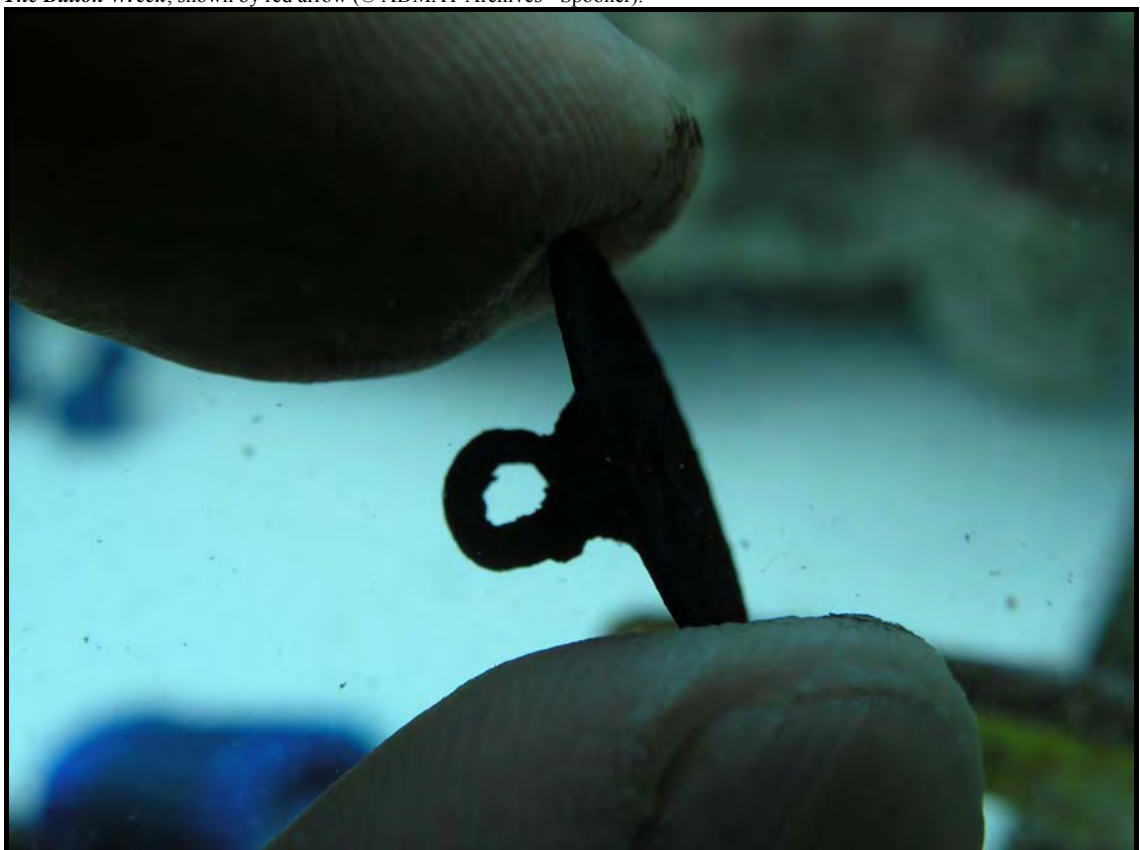
Illustration 106: Artefact BW/2005/NF/Pb/008, copper alloy which was after conservation confirmed as a brass button found on *The Button Wreck* (© ADMAT Archives - Spooner).

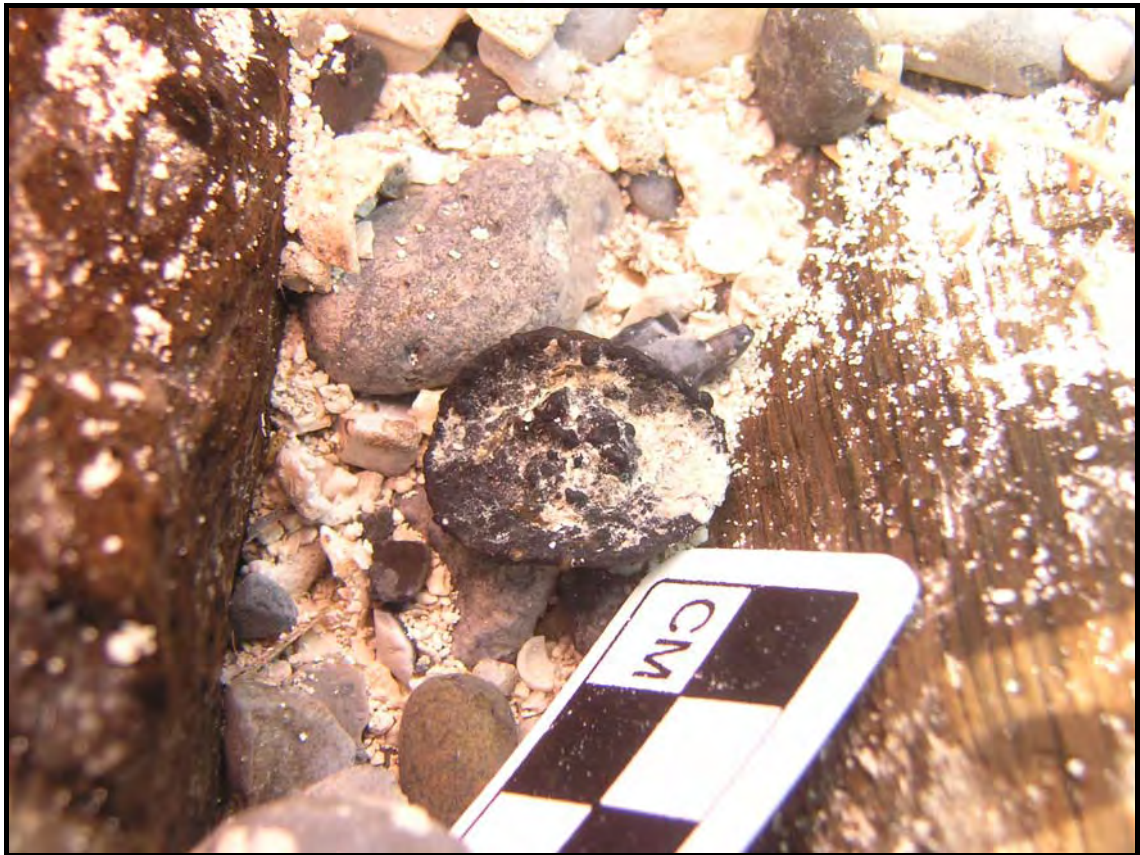
Illustration 107: Artefact BW/2005/NF/Pb/009, a white metal which was after conservation confirmed as a pewter button found on *The Button Wreck*, (© ADMAT Archives - Spooner).

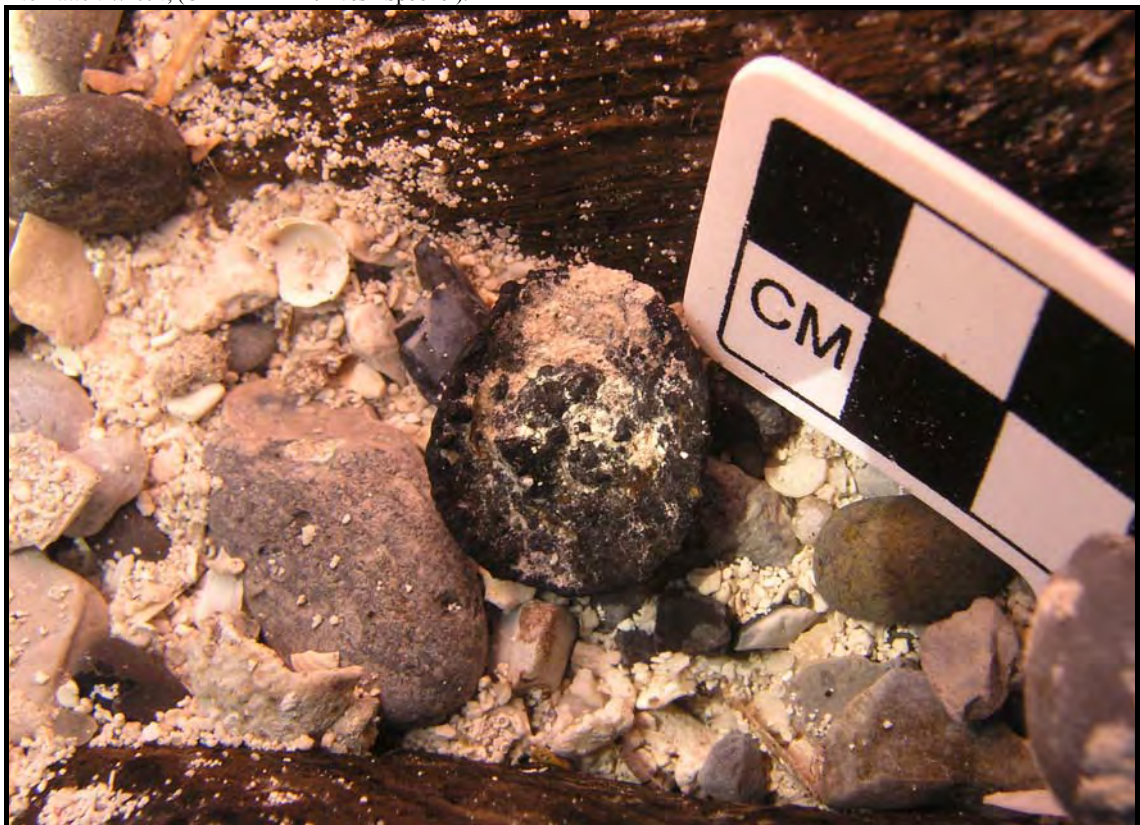
Illustration 108: Artefact BW/2005/NF/Pb/009, a white metal which was after conservation confirmed as a pewter button found on *The Button Wreck*, (© ADMAT Archives - Spooner).
