A . D . M . A . T .

Anglo ~ Danish Maritime Archaeological Team

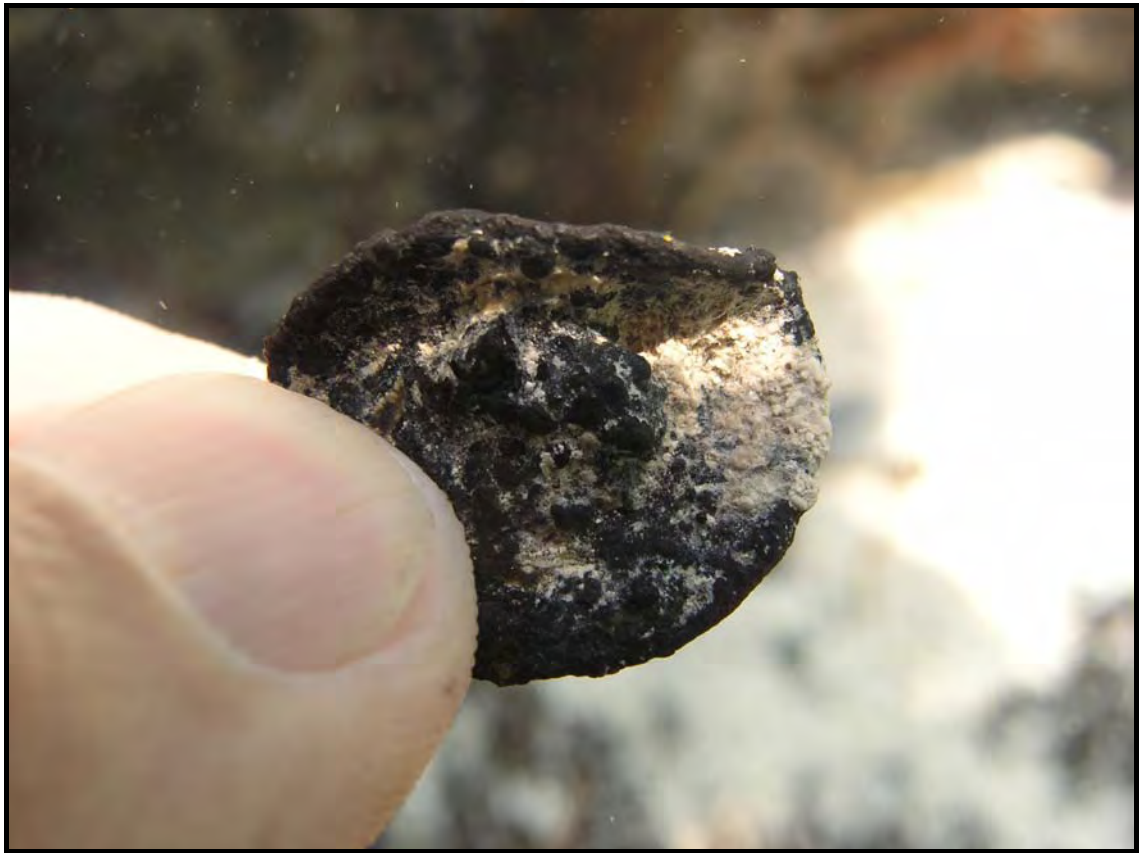
Illustration 109: Artefact BW/2005/NF/Pb/009, a white metal which was after conservation confirmed as a pewter button found on *The Button Wreck* (© ADMAT Archives - Spooner).

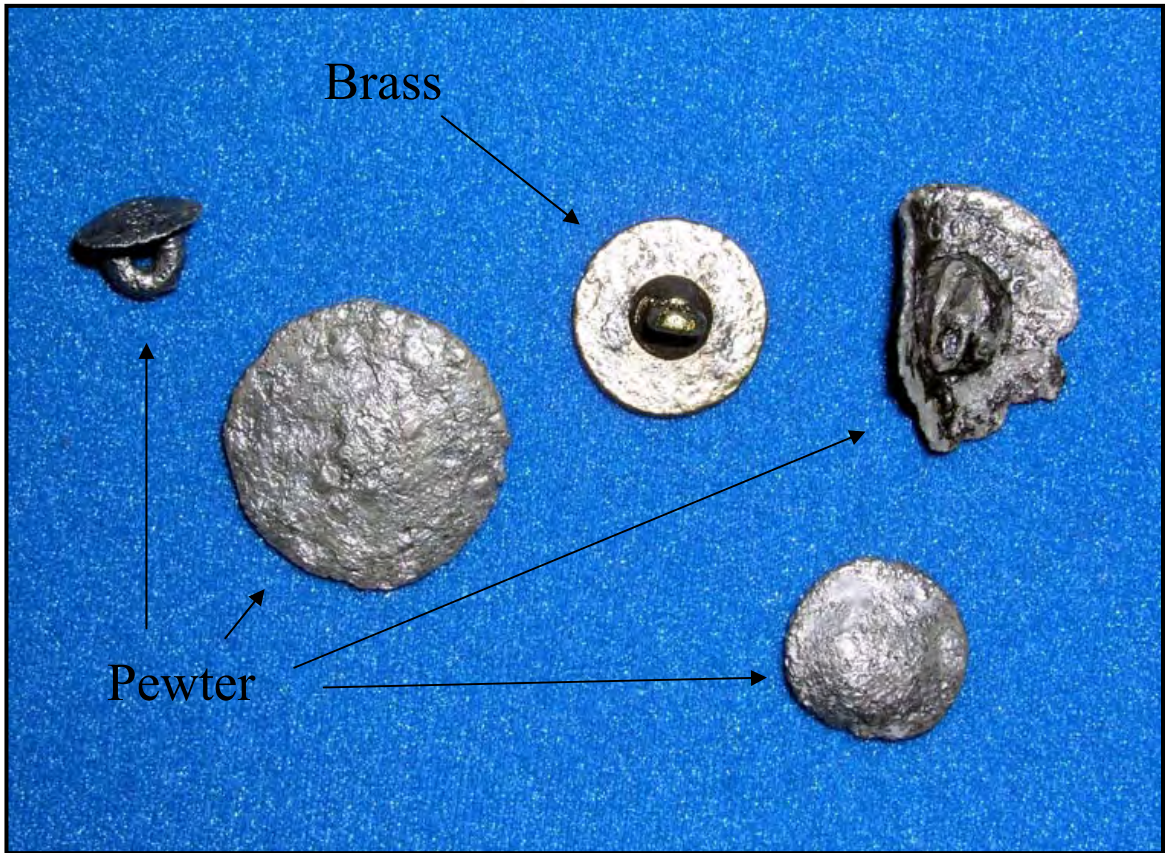
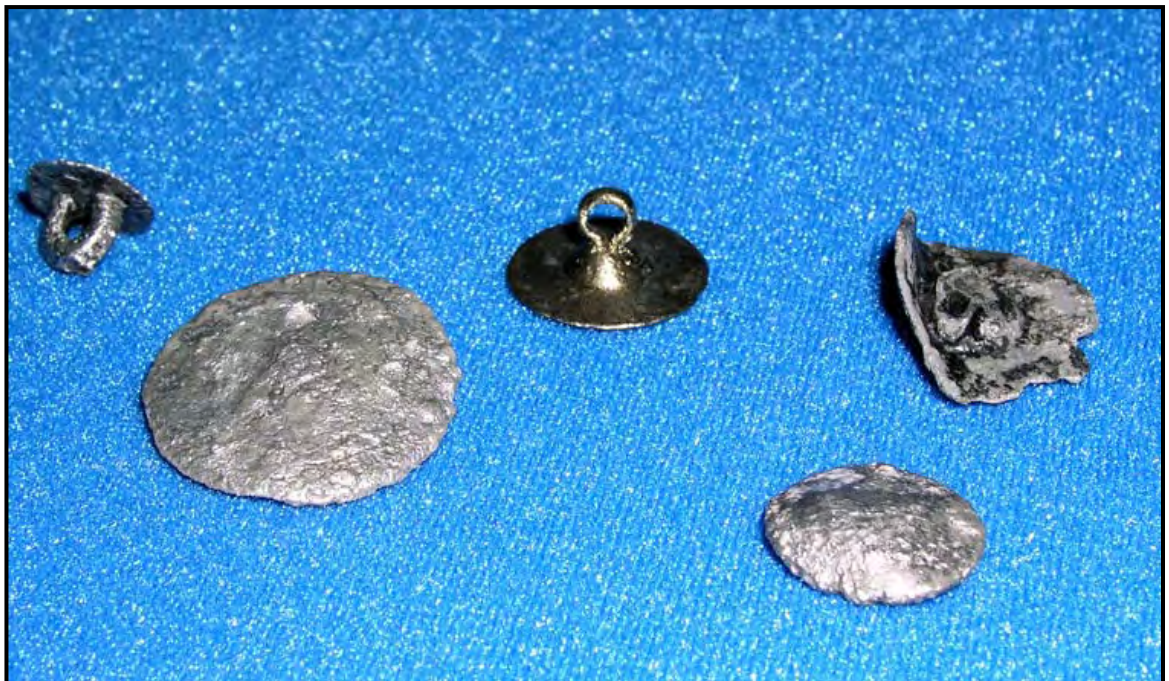
The next three illustrations are from a word document sent by NOAA, who took these photographs and illustrated them. Unfortunately there is no scale in the photographs, and therefore upon ADMAT's return in 2006, these conserved buttons will be fully documented.

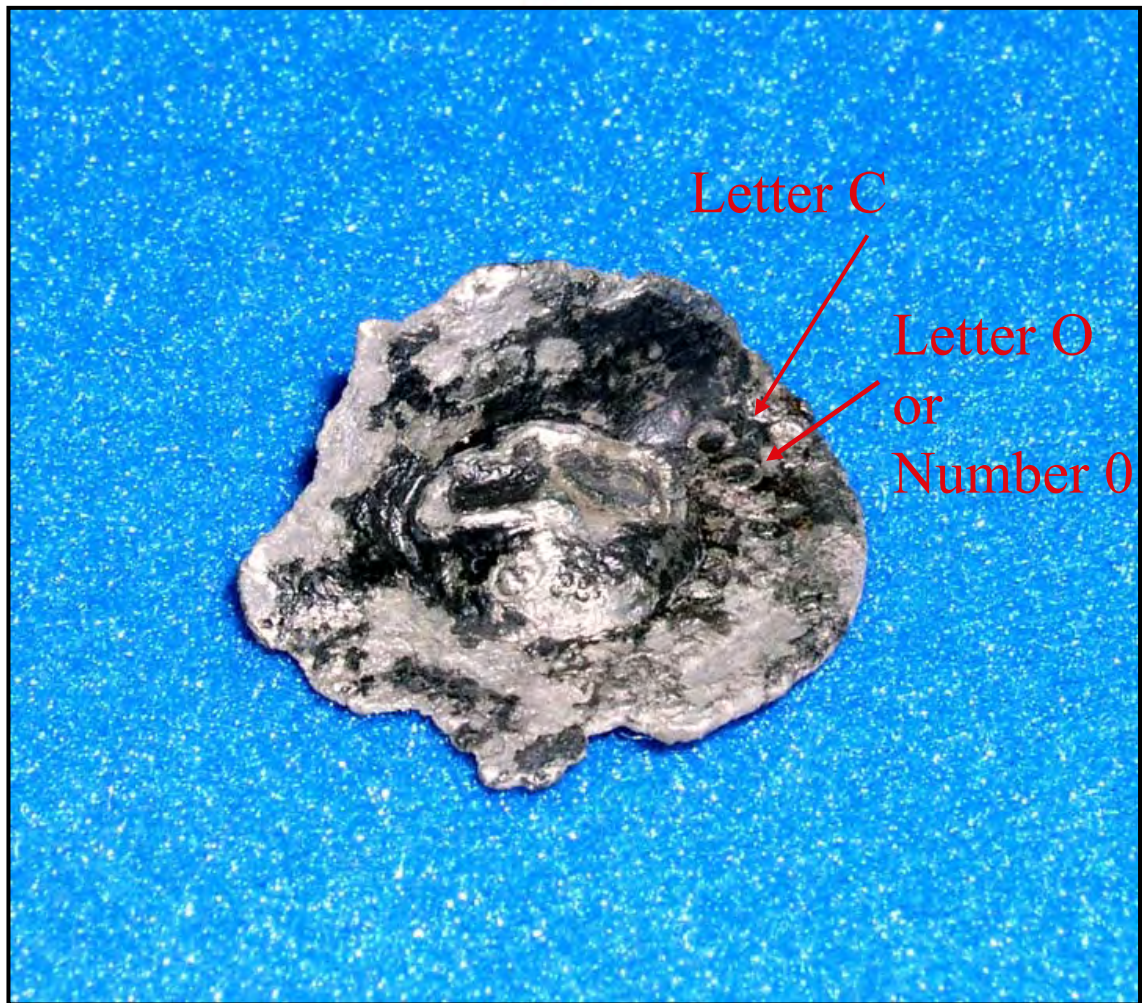
5.4.6 Copper Alloy “Bronze” Slag

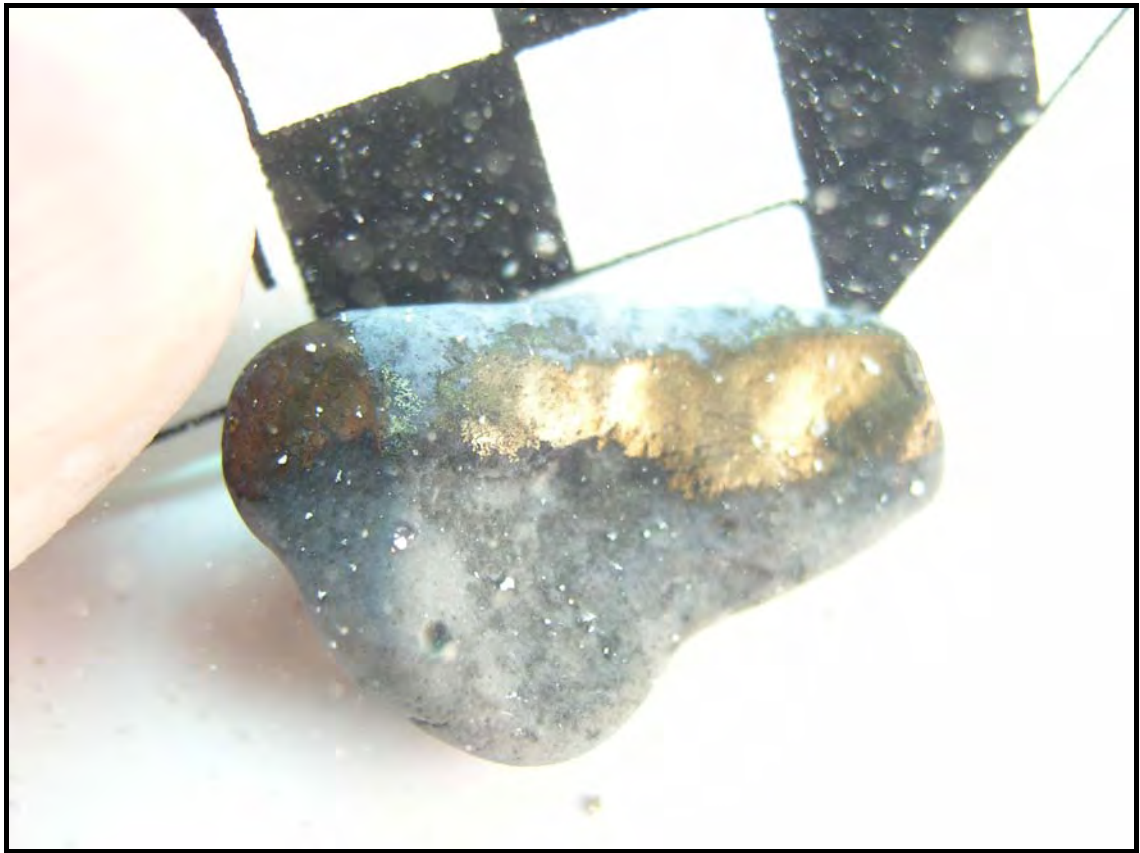
Illustration 110: One of the “Bronze Slag” stones found on *The Button Wreck*. Note the mixed nature of this stone with the “Bronze” effect. (© ADMAT Archives - Spooner).

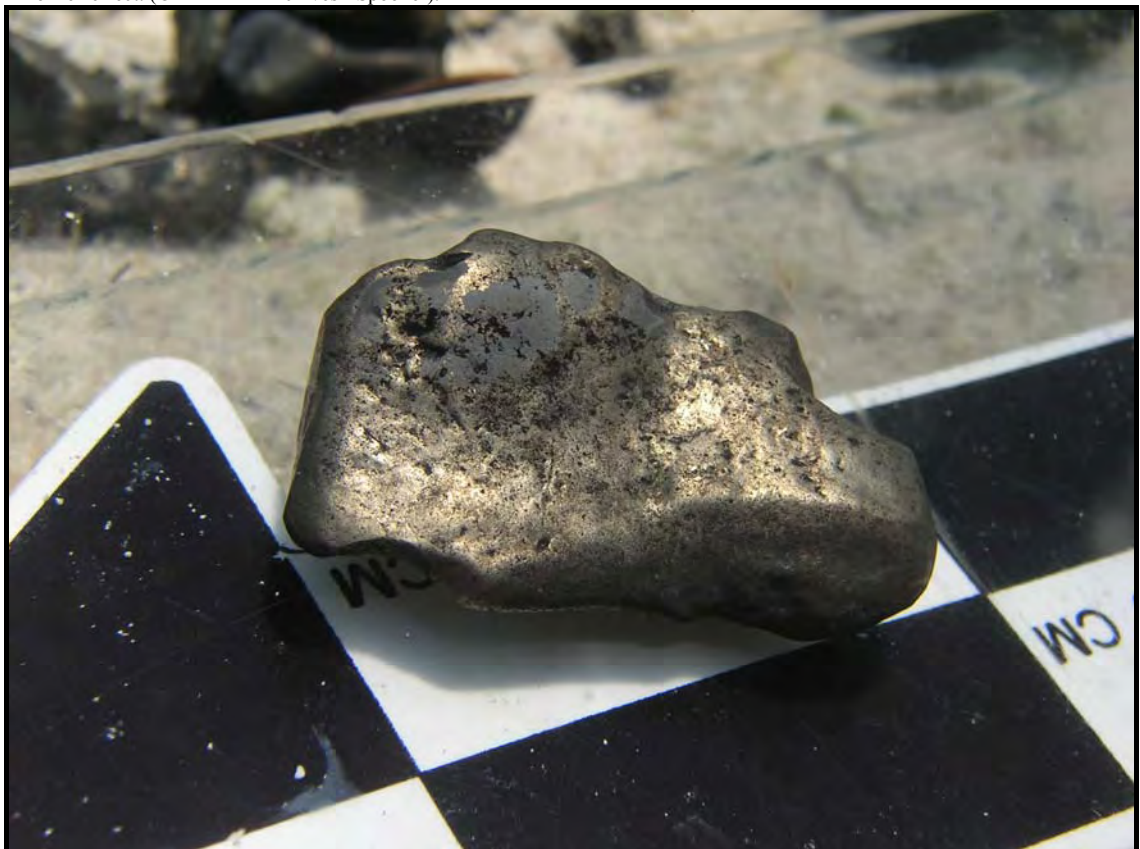
Illustration 111: One of the “Bronze Slag” stones found on *The Button Wreck*. This stone appears to be complete “Bronze” (© ADMAT Archives - Spooner).

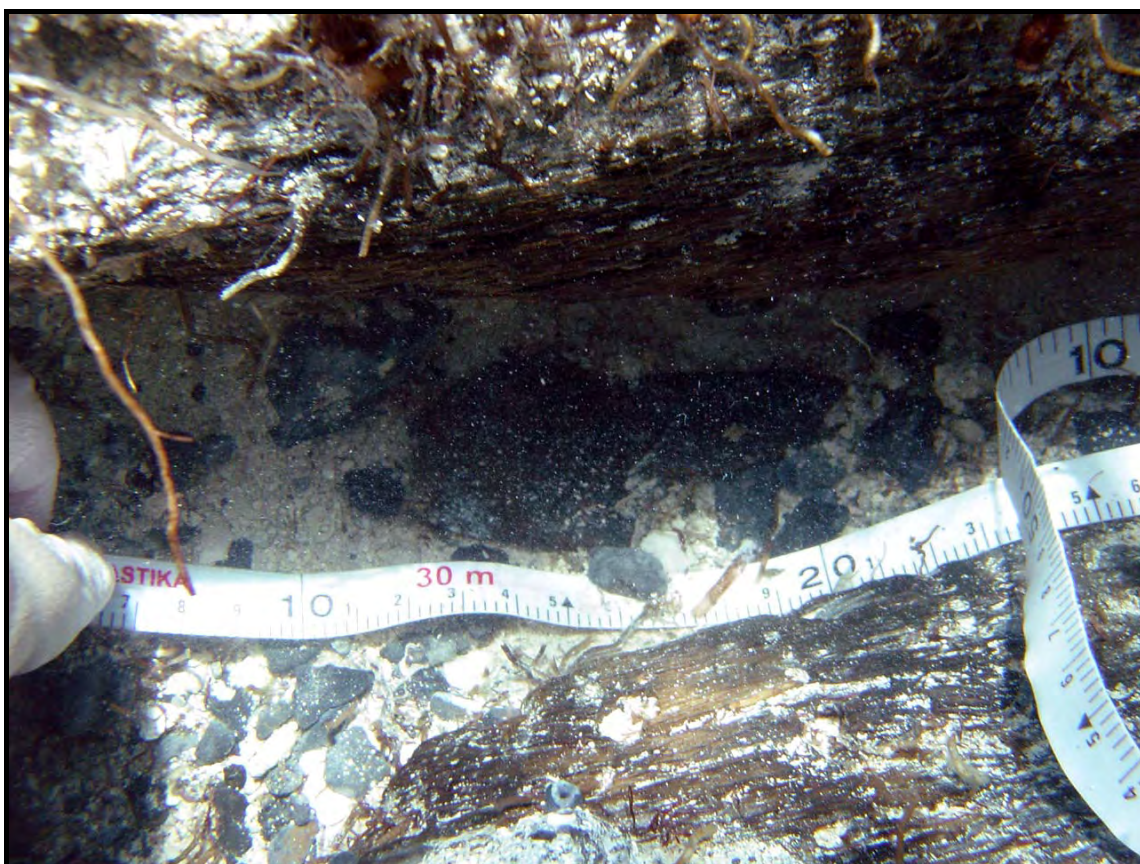
Illustration 112: Location of artefact No: BW/2005/AR/004 in the Aft Deadwood on *The Button Wreck* (© ADMAT Archives - Nielsen).

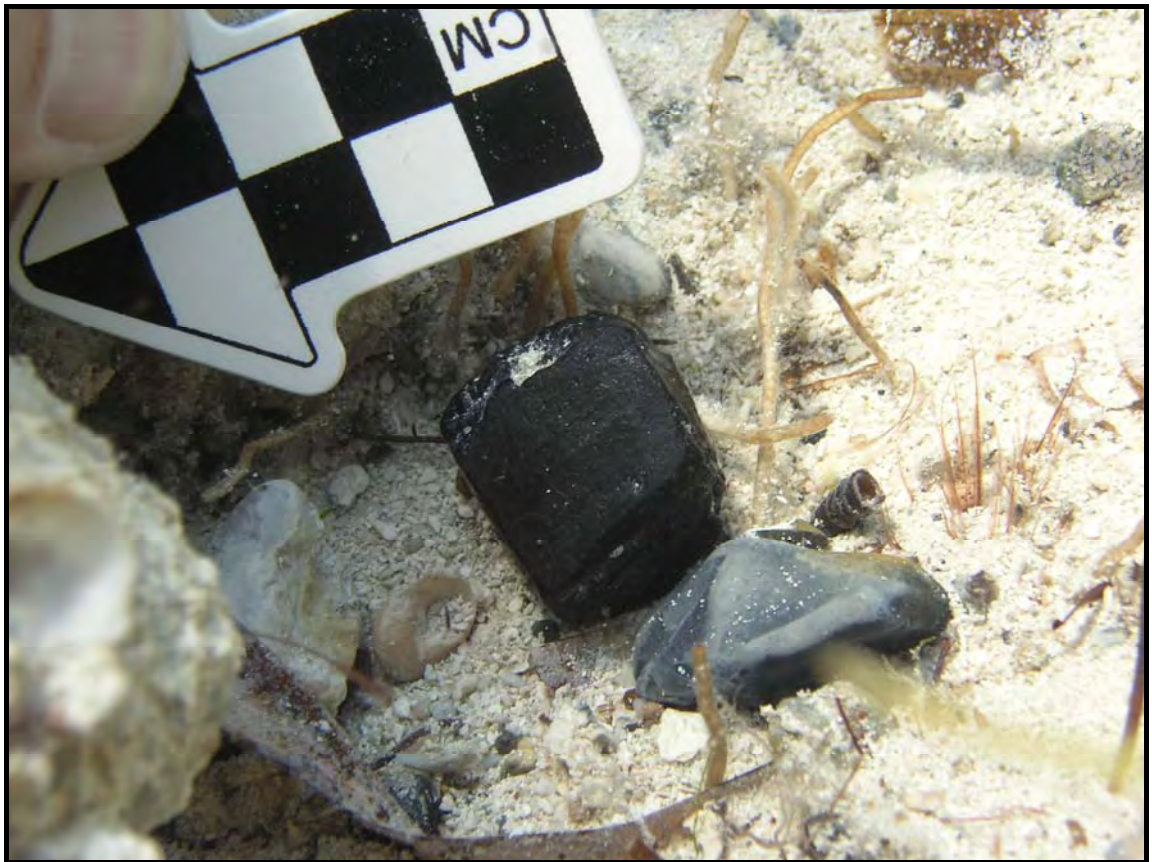
Illustration 115: A piece of charcoal found in the bilges on *The Button Wreck* (© ADMAT Archives - Nielsen).
